## Technical product information

| <b>Topic</b> | Engine coolant - Overheat condition - Warning evident within the DIP - DTC's P2B6500 and P2B8600 are evident |

### W12-New Continental GT/GTC (All variants) & New Flying Spur

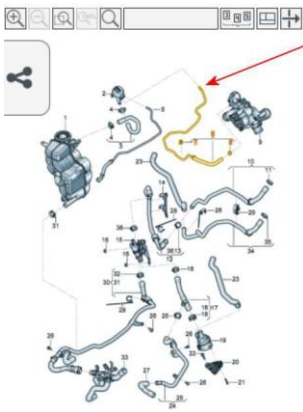
2) Referring to Figure 2 - Locate the vent hose shown (975 122 447H)

4) Replace the vent line

- Once the vent line has been replaced - Referring to Rep.Gr 19 - Bleed the coolant system
- Erase all applicable DTC's
- Conduct a road test - On return check to confirm that no coolant related DTC's are evident

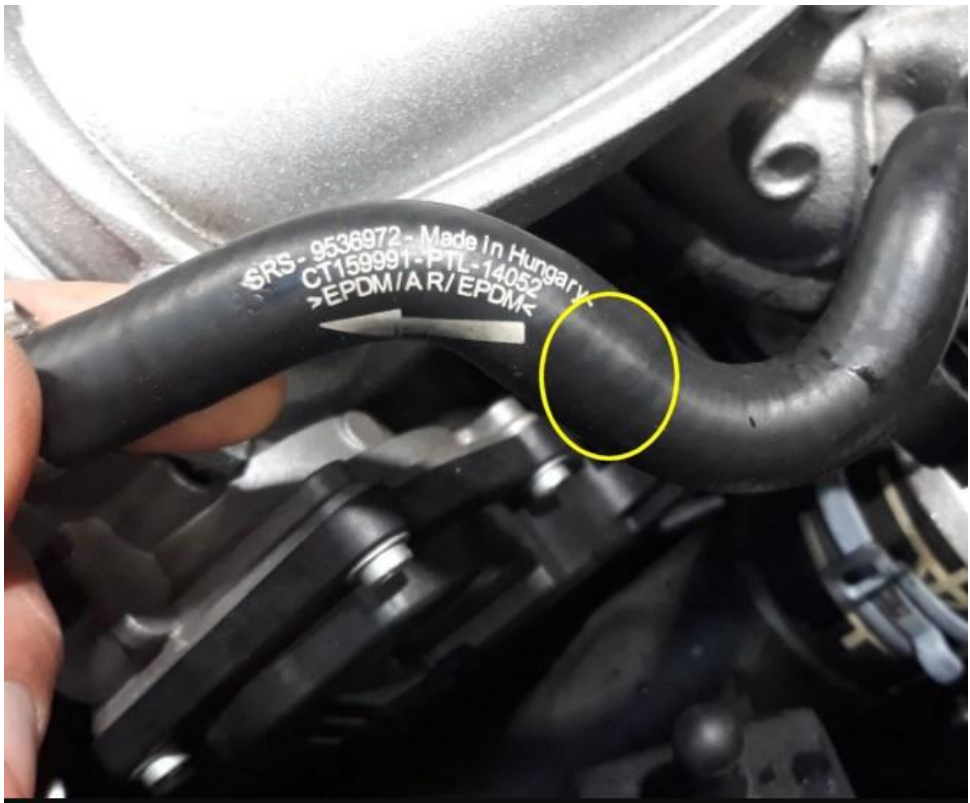
- The vent hose has an internal check valve, the valve is positioned within the vent hose at the location shown in Figure 3 (Circled)

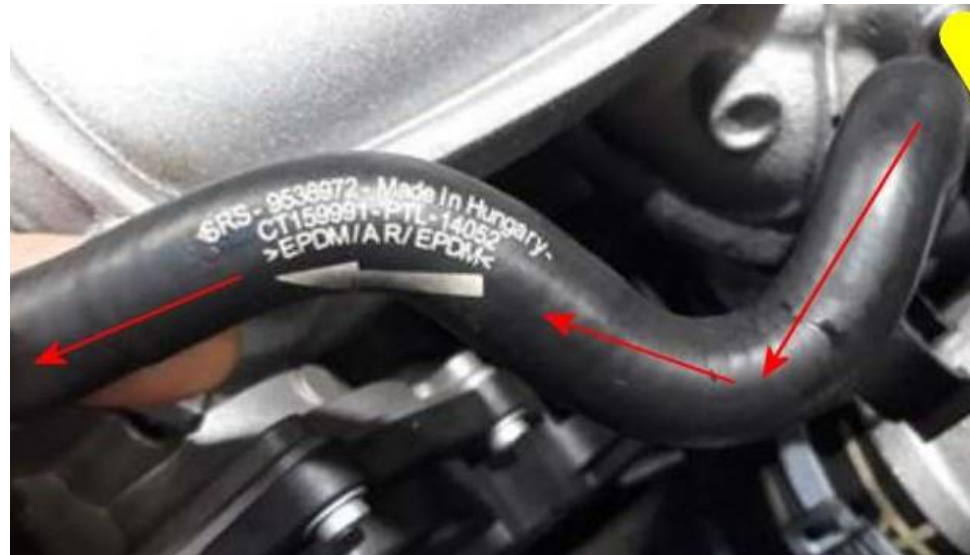
- Referring to Figure 4 - The coolant flows in the direction shown (Arrows) in the event the internal check valve is faulty the flow of the coolant will be restricted (Causing the symptoms described within the customer findings/workshop findings section)

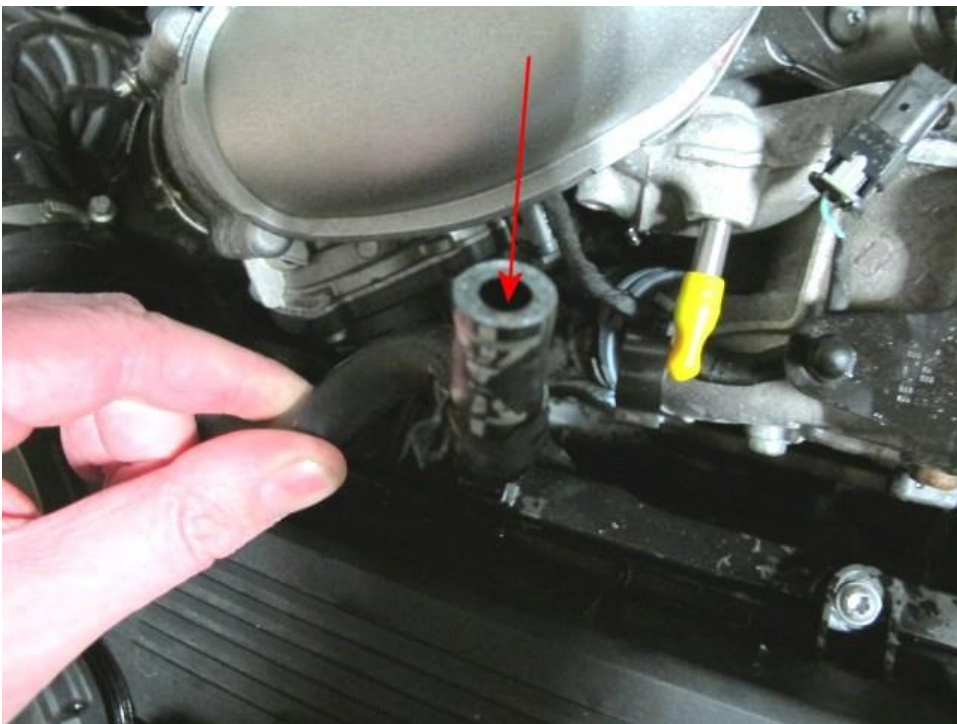
Does the air flow through the vent line without any restrictions?

5) Referring to Figure 8 - Apply light air pressure into hose (Arrow)

No - Go to step 4

Yes - Raise a DISS query and await feedback before conducting any further work
