# Service Bulletin

Bulletin No.: 18-NA-115

Subject: Cold Start Misfire and/or Rough Idle – DTC P0300 May Be Set

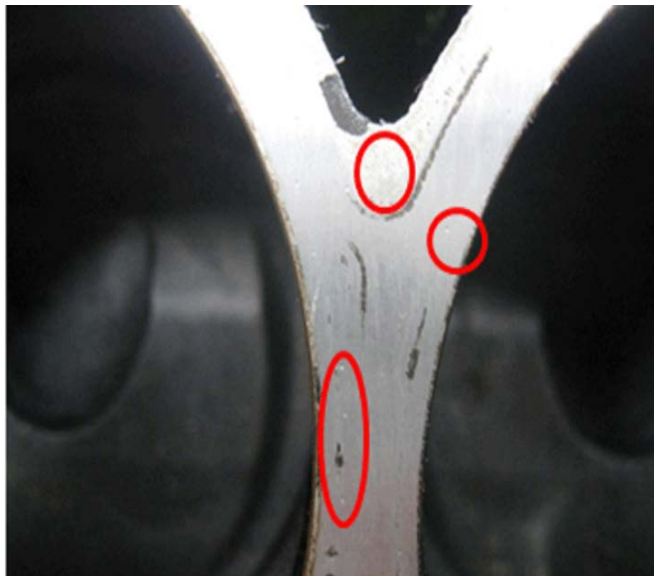
3632858

Notice: Small surface pock marks or pitting appearance on the deck surface is normal and an engine should not be replaced for any such appearance marks as they do not connect to the engine coolant passages and cause a leak path that will generate engine misfires.

6. With the cylinder head removed, perform a visual inspection. Reference the following pictures provided. The first two pictures represent normal examples of deck pitting and are not the cause of the misfire and/or rough idle condition.

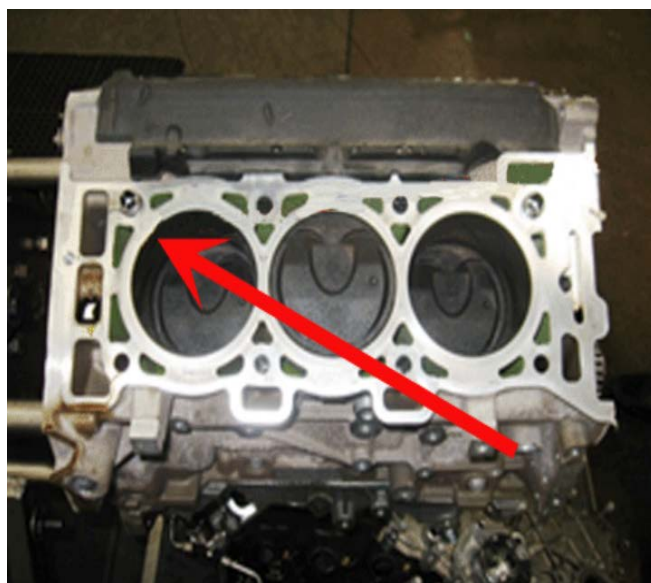
3632865

7. The two following pictures represent an example and the location of how actual engine cylinder block porosity appears. This would be a cause of the condition.

Shown at the deck face to cylinder liner interface location is an area of engine cylinder block porosity that has caused an engine coolant leak path into the cylinder, causing medium to high misfire counts when the engine is cold.

⇒ If this condition is verified, the engine must be replaced.
