# TECHNICAL SERVICE BULLETIN

## Various Concerns With The Active Exhaust System

**22-2153**

**Ford**  
2018-2022 Mustang

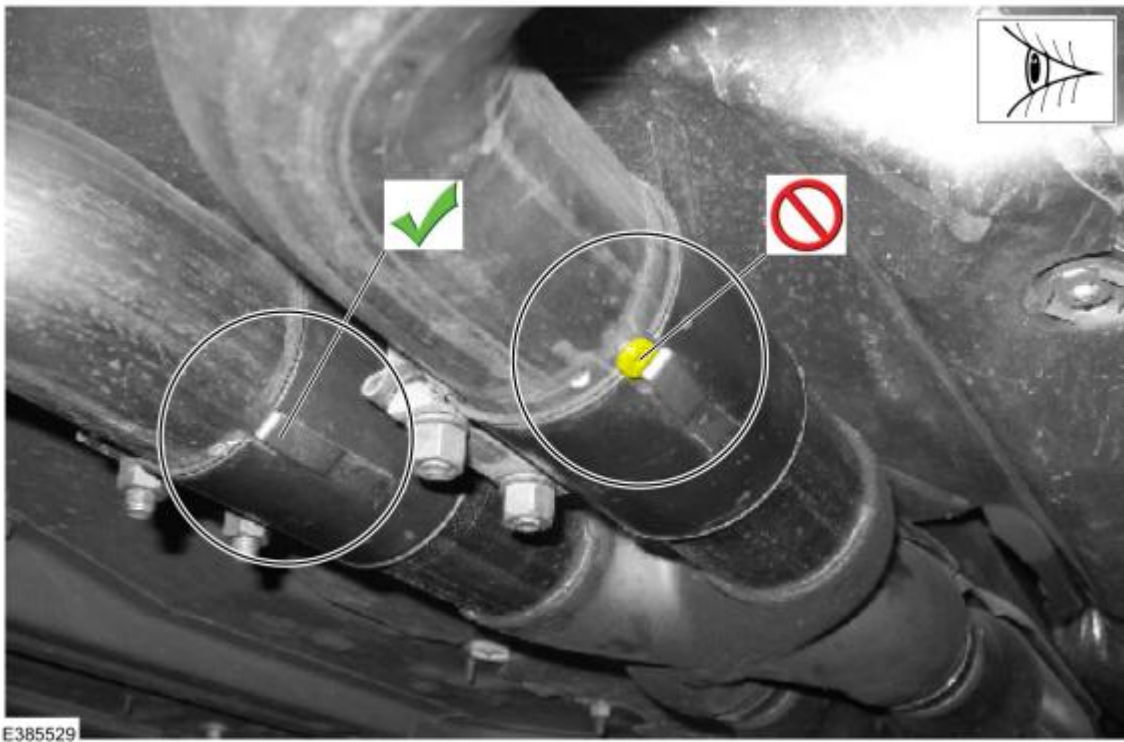
Figure 1 - Exhaust clamp locking tabs

4. Is the concern still present?
  - (1). Yes - proceed to Step 5.
  - (2). No - repair is complete.
5. Inspect the muffler and tailpipe assembly and both catalytic converters for proper positioning in the exhaust clamps which secure them together. Make sure the exhaust clamp locking tab is fully engaged to the catalytic converters (Refer to Figure 1). Make sure the knurled/ridge area of the muffler and tailpipe assembly are covered by the exhaust clamps (Refer to Figures 2-3). Adjustments can be made by loosening the exhaust clamps and repositioning the muffler and tailpipe assembly. (Figures 1-3)

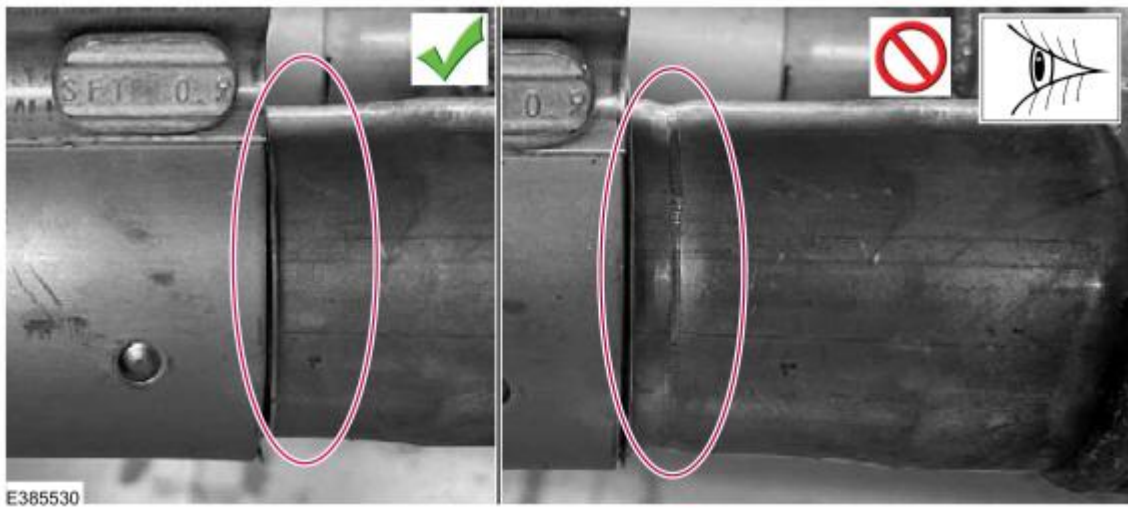
Figure 2 - Non-GT500 exhaust with ridge

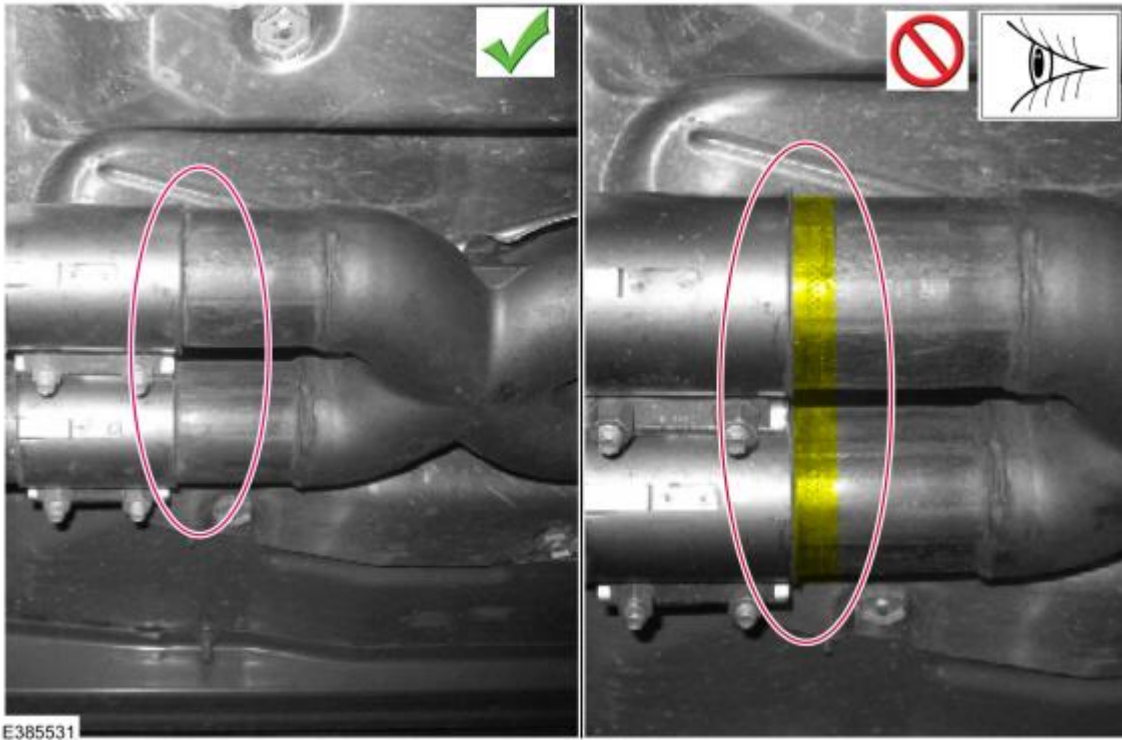
Figure 3 - GT500 exhaust with knurled area
