PIT5885A Service Restraint System Message / Air Bag Warning MIL / DTC B14DC Set

Product Investigation Review Required

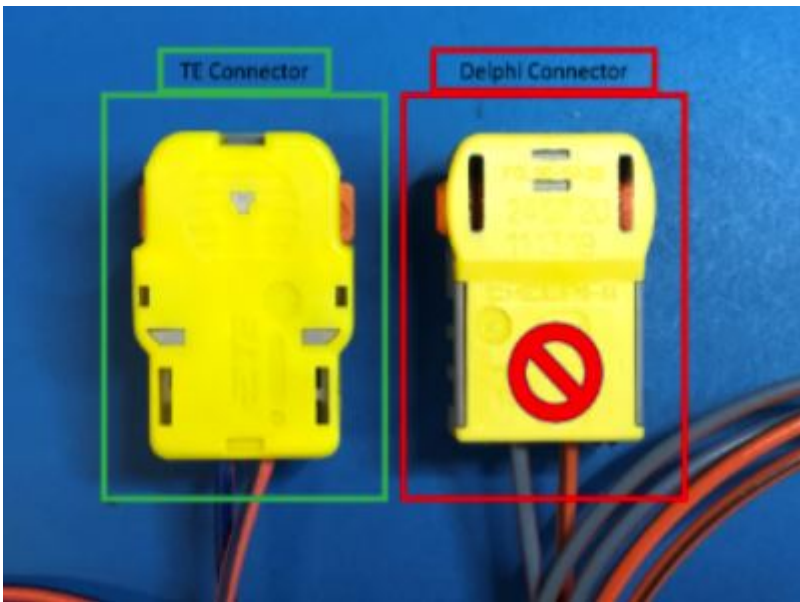
| Cause | The cause of the condition may be the driver's seat side airbag connector coming in contact with the seat back cushion. Thus, during movement from the driver, or while adjusting the seat, it may cause the airbag connector terminals to temporarily lose contact, causing the issue. |

5. On the lower right side of the seat, pull back the seat cover to expose foam and locate the seat airbag connector.

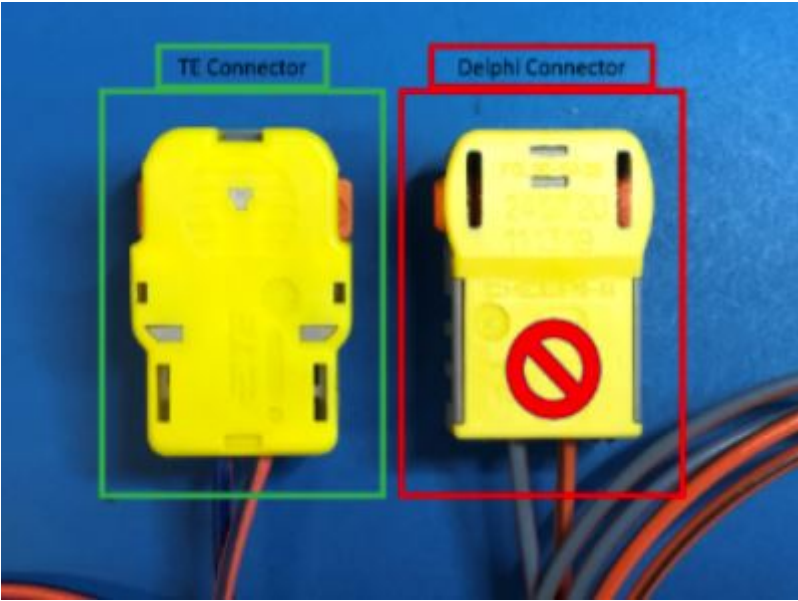
- 5. On the lower right side of the seat, pull back the seat cover to expose foam and locate the seat airbag connector.
