# Technical Service Bulletin

91 SOS Emergency call function deactivated message in the cluster, DTC U153E00 is stored in the telematics module

91 22 99 2055945/9 May 5, 2022. Supersedes Technical Service Bulletin Group 91 number 21-49 dated November 17, 2021 for reasons listed below.

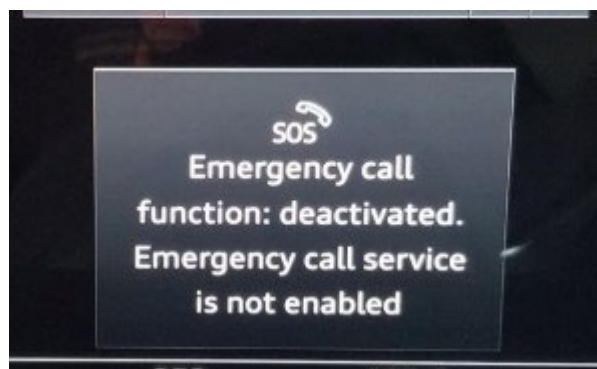
- The warning message “SOS Emergency call function deactivated” is seen in the instrument cluster (Figure 1 or 2).

Figure 1. SOS warning in the instrument cluster.

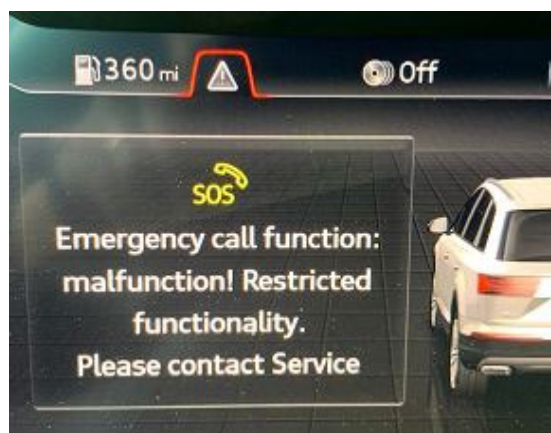
Figure 2. SOS warning in the instrument cluster.
