RS19-005B

ITB19-024B

April 26, 2022

## DTC B00A0-00 STORED

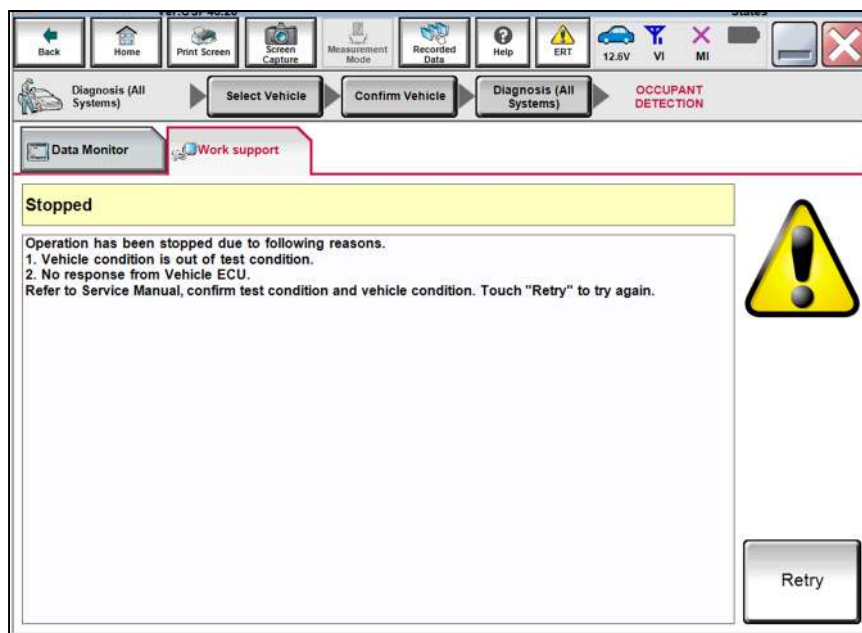
Figure 1

DTC B00A0-00 (OCCUPANT DETECTION SENSOR UNIT) is stored,

OCS zero point reset cannot be performed,

The following screen will display:

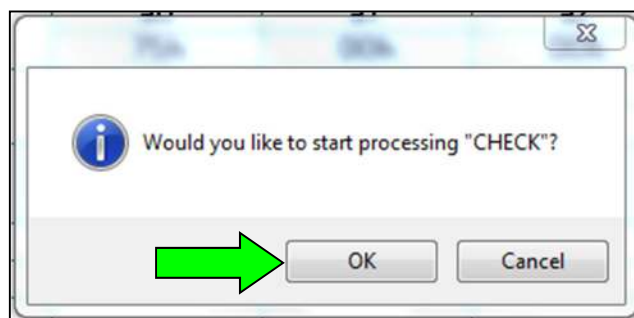
Figure 5

11. Check for code 75h to show under CURRENT FAILURE CODE.

- If code 75h shows under CURRENT FAILURE CODE, go to step 12.
- If code 75h does NOT show under CURRENT FAILURE CODE, STOP HERE.  
This bulletin does not apply. Refer to ASIST and the ESM for further diagnostic assistance.
