## TECHNICAL SERVICE BULLETIN

### 3.0L, 6.7L - Illuminated MIL With Various Reductant System Related DTCs

**22-2191**

16 May 2022

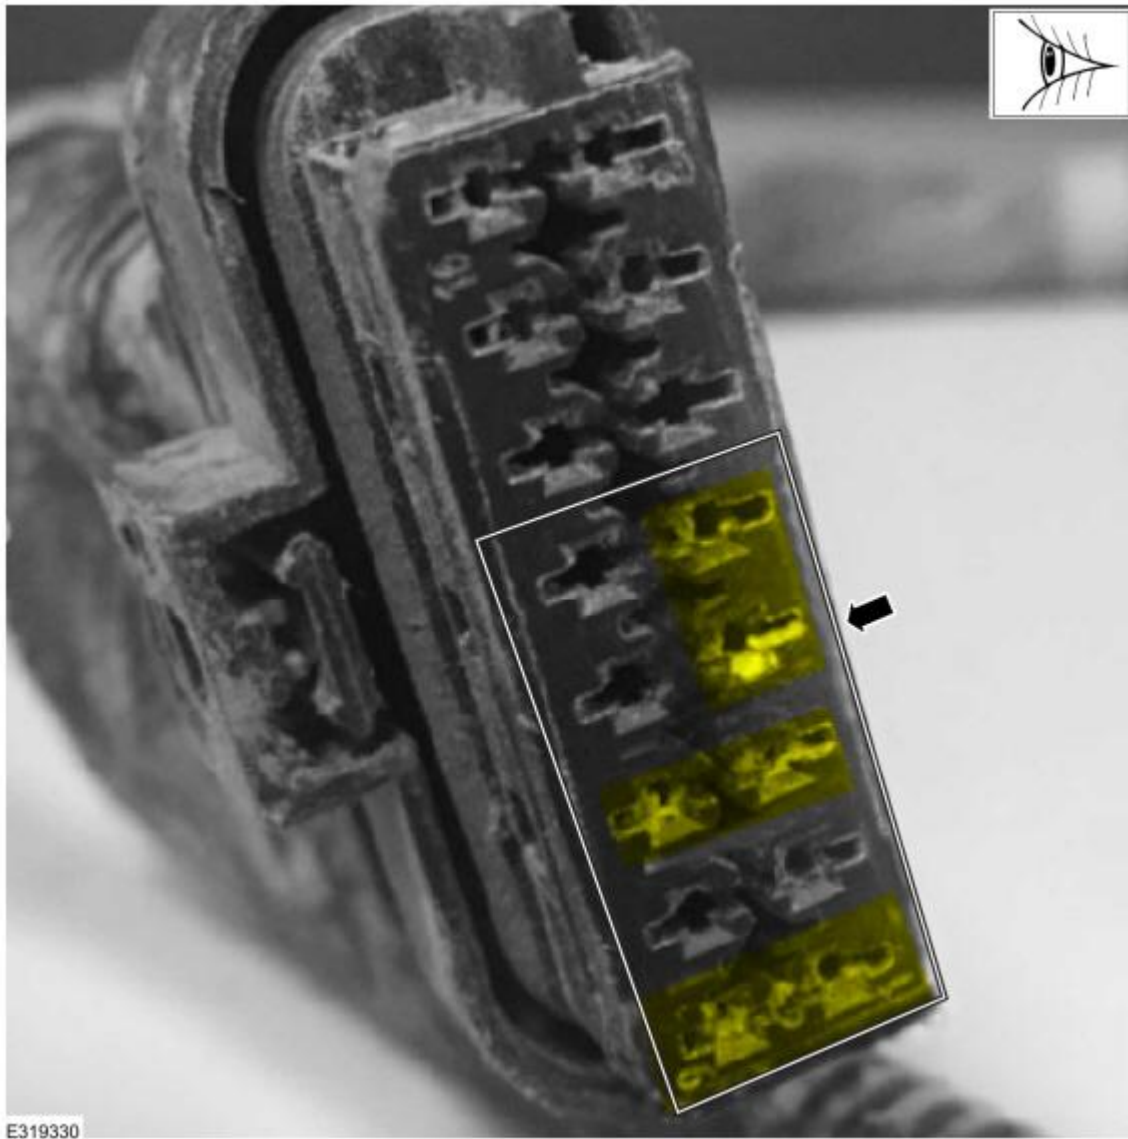
Figure 1

- Visible green corrosion on multiple terminals on the harness side of connector C3613. (Figure 1)

- (1). If no signs of corrosion or water intrusion are present on either connector or component, replace the red ductant tank harness only.
- (2). If signs of corrosion or discoloration are present on the red ductant tank harness connector C3613 or red ductant pump/heater assembly perform the following:

- If there is corrosion or discoloration on the red ductant tank harness connector only and not on the red ductant pump/heater assembly, only replace the red ductant tank harness.

- If there are signs of corrosion or discoloration on the red ductant pump/heater assembly, replace both the red ductant tank harness and the red ductant pump/heater assembly. Refer to WSM, Section 303-08.
