# Service Bulletin

Bulletin No.: 21-NA-005

**Subject:** Airbag Malfunction Warning and Airbag Malfunction Indicator Illuminated with DTC B0001-1B or B0012-0D

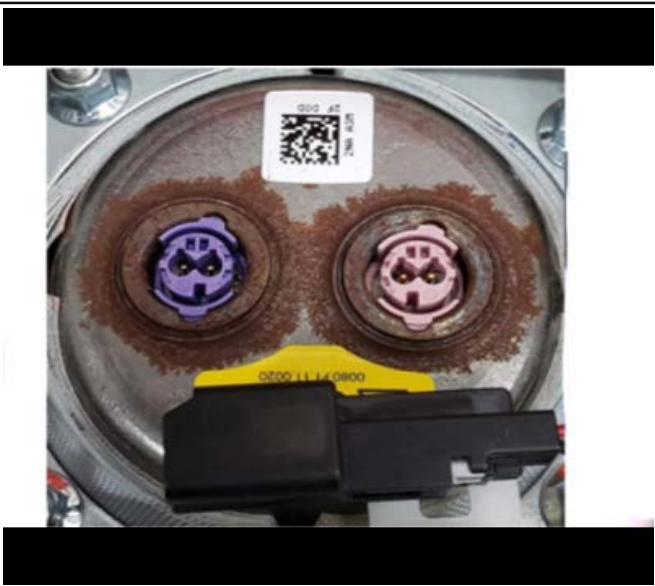
| Cause | <p data-bbox="1419 741 1479 758">5704083</p> <p data-bbox="540 768 1419 821">Cause of condition may be rust particles, or other contaminants trapped within connection terminal interface causing excessive resistance seen in the airbag loops.</p> |

| Correction | <p data-bbox="540 835 1435 884">In order to correct the condition, the following steps must be followed to ensure proper root cause:</p> |
