# Service Bulletin

Bulletin No.: 21-NA-176

Date: December, 2021

**Subject:** Airbag Warning Lamp Illuminated on Driver Information Center (DIC), DTC B0017 01 B0024 01 or B001E 01 Set

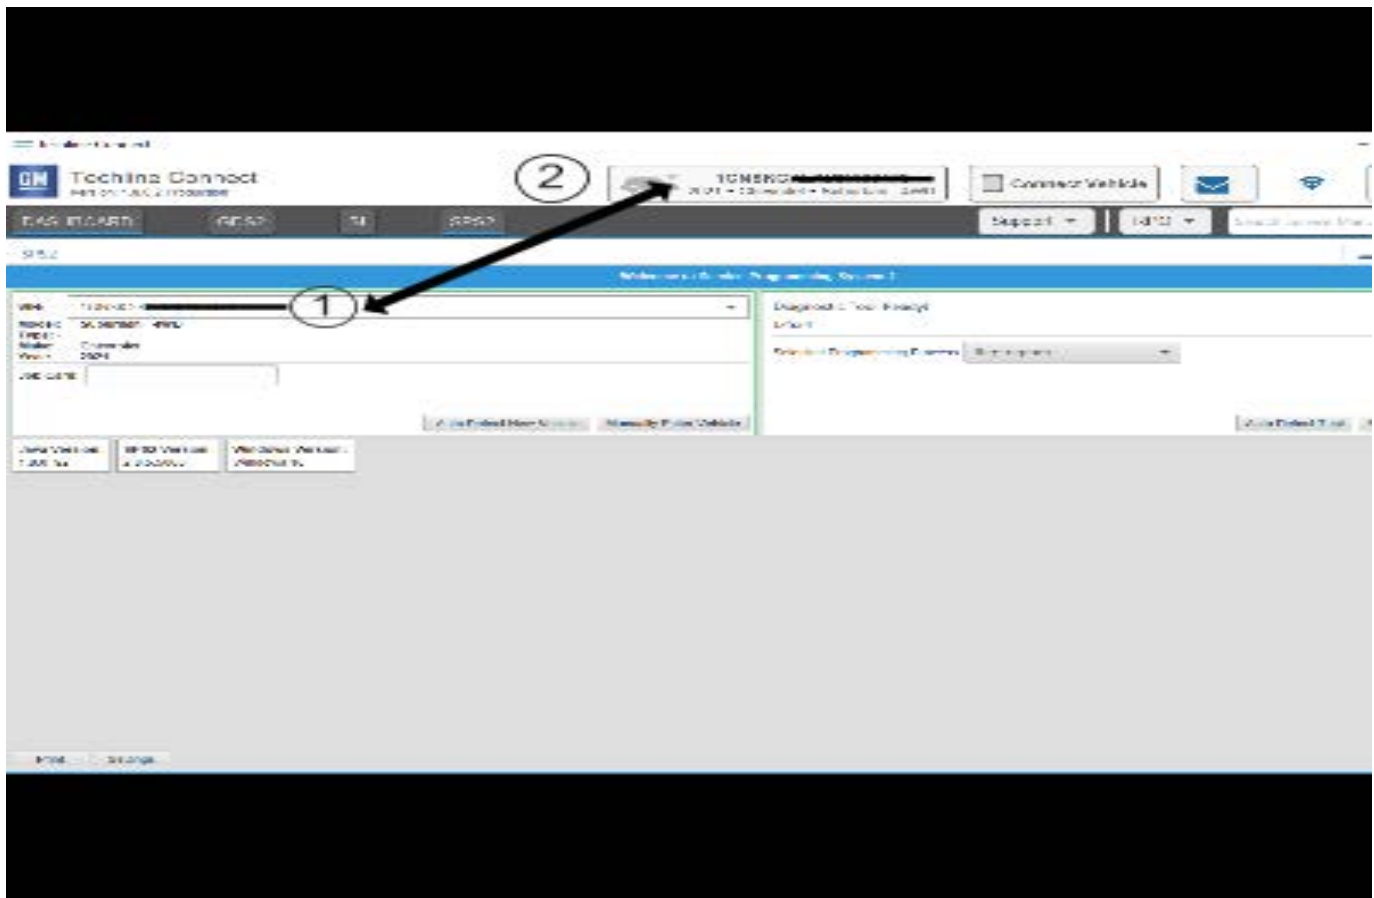
5743643

Caution: Be sure the VIN selected in the drop down menu (1) is the same as the vehicle connected (2) before beginning programming.

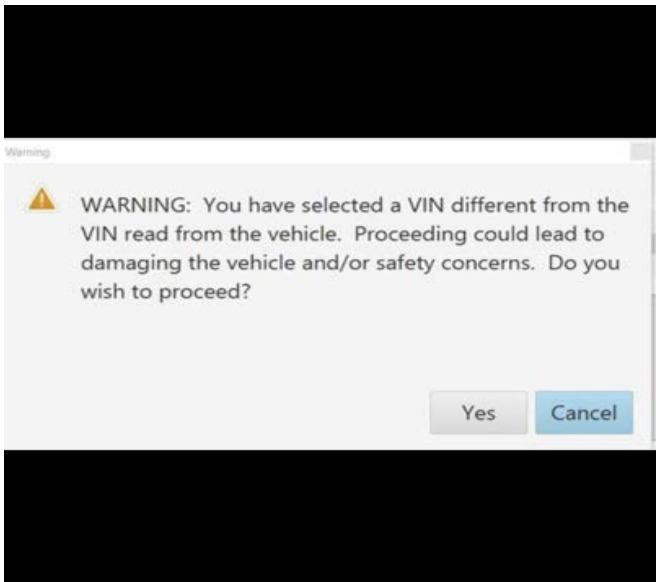
5877000

Important: If the vehicle VIN DOES NOT match, the message below will be shown.
