# Service Update

## 18348 Shifter Stuck in Park with DTC P189D

Reference Number: N182193580

Models: 2019 Cadillac XT4

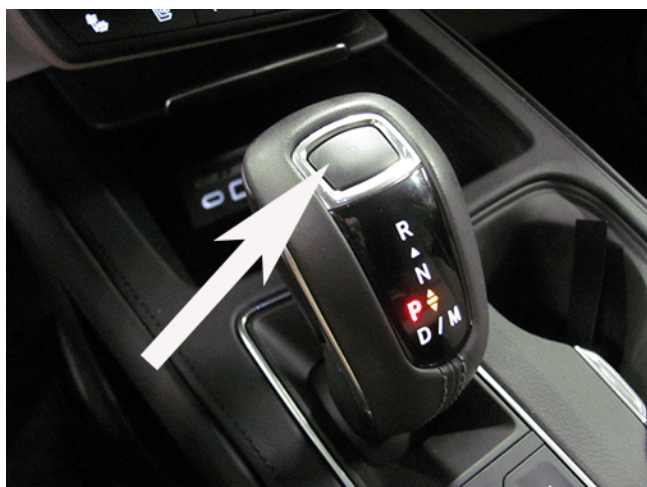
5156828

**Note:** During the cycling of the park button, there is the potential to induce faults when the button is cycled quickly that will generate other DTCs resulting in the "Service Shifter" warning. The technician should still complete the cycling and updating the ECM. DTCs will pass after the park button is pressed in a normal, non-repeated manner.

1. Cycle the park button on the transmission electronic control 100 times, use the following pattern. Depress the button for one second and release for two seconds, repeat the one second depressed, two second released for one hundred cycles.
2. Reprogram the engine control module (ECM). Refer to *K20 Engine Control Module: Programming and Setup* in SI.
3. Record SPS Warranty Claim Code on job card for warranty transaction submission.
