# Service Bulletin

Bulletin No.: 22-NA-007

**Subject:** Poor Engine Performance in Extremely Cold Weather Conditions for LE2 Engines, Charge Air Cooler (CAC) Icing - Malfunction Indicator Lamp (MIL) Illuminated, DTC P0299, P0234, P0236, P2227, P00C7 Set

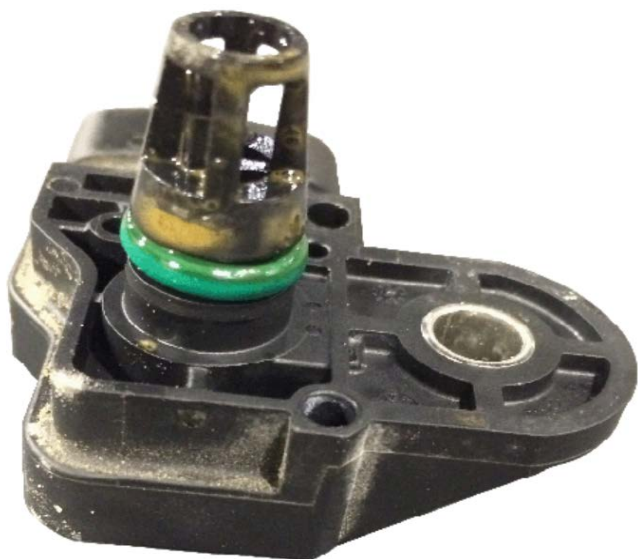
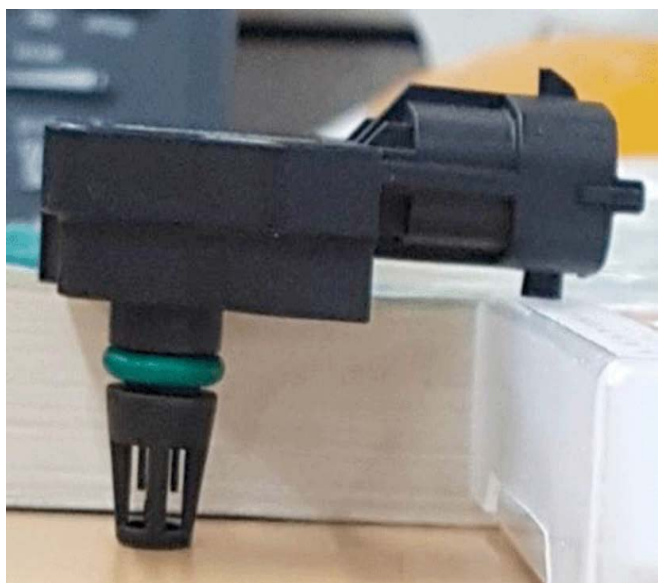
5020216

2. Inspect the sensor for any contaminants.

3. Allow time for any ice build-up to melt by placing the sensor port down.
4. Clean the sensor with a clean towel.
5. Install the sensor. Refer to Turbocharger/Supercharger Boost Pressure Sensor Replacement in SI.
