## G-MOPF 2018: Warning message "Water fording not possible"

| Topic number | LI09.00-P-074794 |
| Validity | Model 463.260/261/276/277 MOPF with modification year 19 (code XZ9), modification year 20 (code X20) or modification year 20/3 (code ZX9) |

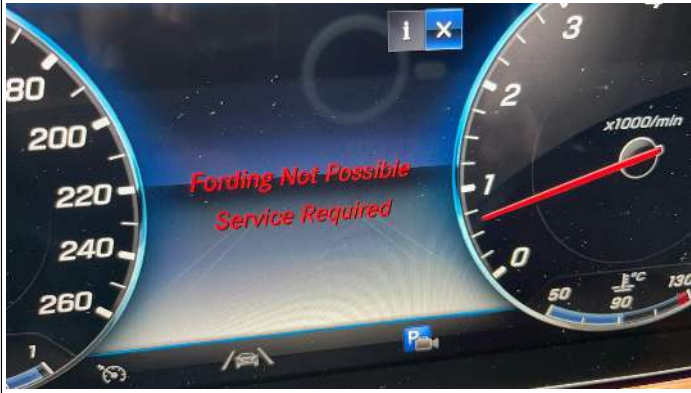
Customer reports a warning message in red in the instrument cluster: "Water fording not possible! Service required". The message is no longer active following an ignition cycle.

| Attachments | |
|---|---|
| <a href="#">Fehlermeldung Englisch.jpg</a> | Fault message in instrument cluster (English) |

As a result of an absent or aborted reference run of the air flaps of the N127 'drivetrain' control unit (PTCU), the fault codes P153001 and P153101 are stored in the fault memory and the "Water fording not possible" warning message appears in the instrument cluster. The flap system nevertheless functions correctly.

1. Perform software update of the N127 'powertrain' control unit (PTCU) (XENTRY data status 12/2021 or more recent)
2. Check function of air flaps M108/1 and M108/2 through actuation
