# TECHNICAL SERVICE BULLETIN

| AT22-003 | ITB22-018 | April 19, 2022 |

## “SERVICE AT POWER REDUCED” WARNING DISPLAYED AND DTC P0715 STORED IN THE TCM

**APPLIED VEHICLES:** 2022 QX60 (L51)  
**APPLIED DATES:** Built before March 21, 2022

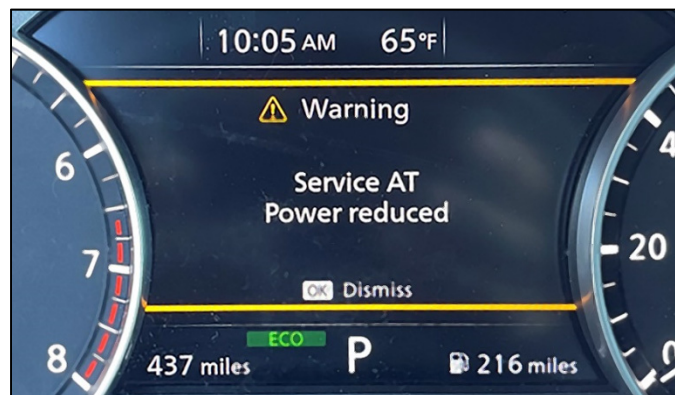
Figure 1

The client states the “Service AT Power reduced” warning message (Figure 1) is/was displayed,

DTC P0715 (INPUT SPEED SENSOR A) is the only DTC stored in the TCM.

1. Confirm the current TCM part number.
2. Reprogram the TCM, if applicable.
