# TECHNICAL SERVICE BULLETIN

| RS19-004B | NTB19-071B | April 26, 2022 |

## DTC B00A0-00 STORED

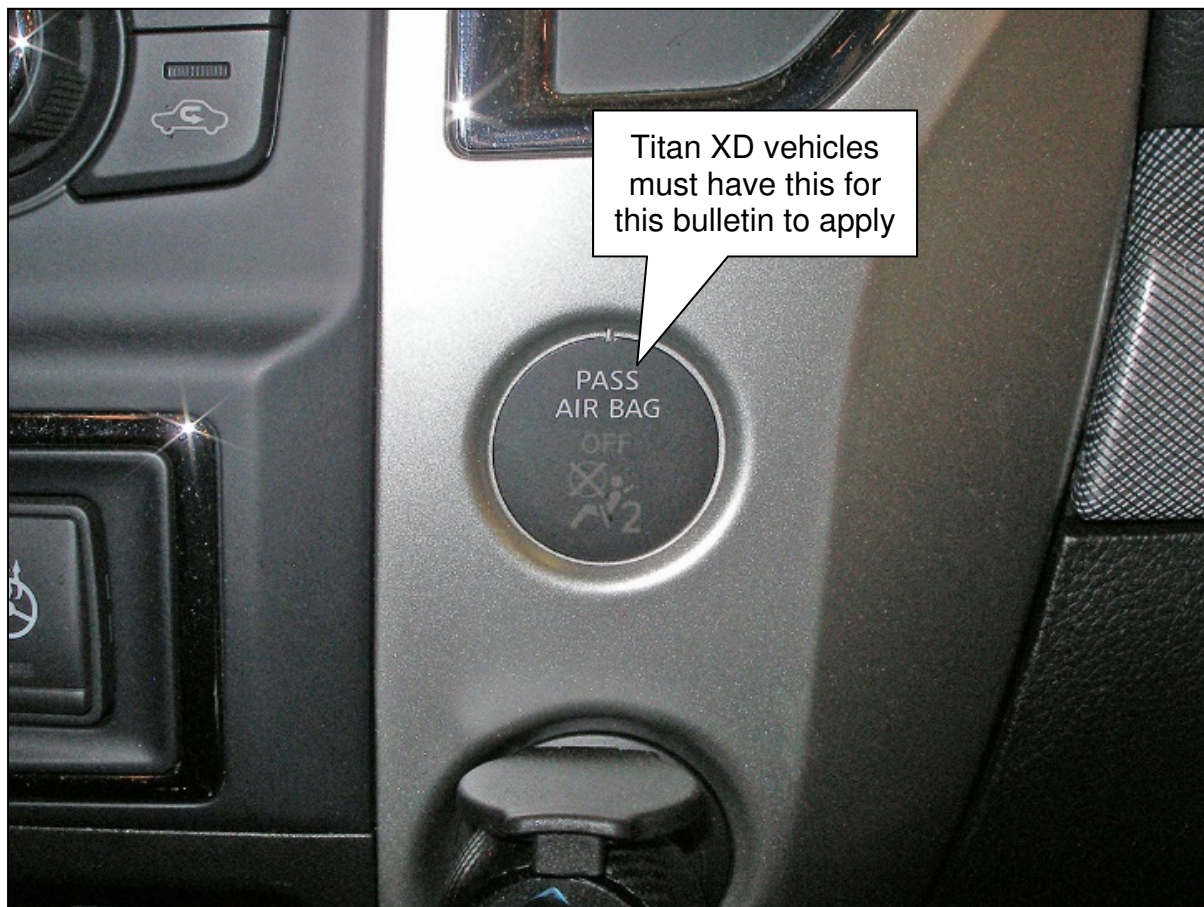
Figure 3

- ASIST on the CONSULT PC has been synchronized (updated) to the current date.
- All CONSULT-III plus (C-III plus) software updates (if any) have been installed.
- The CONSULT PC is connected to the Internet (Wi-Fi or cable).
- Titan vehicles: This bulletin applies to ALL Titan vehicles.
- Titan XD vehicles: This bulletin does NOT apply to all Titan XD vehicles. This bulletin applies to Titan XD vehicles equipped with OCS, as indicated by the presence of a front passenger air bag status light (see Figure 3).

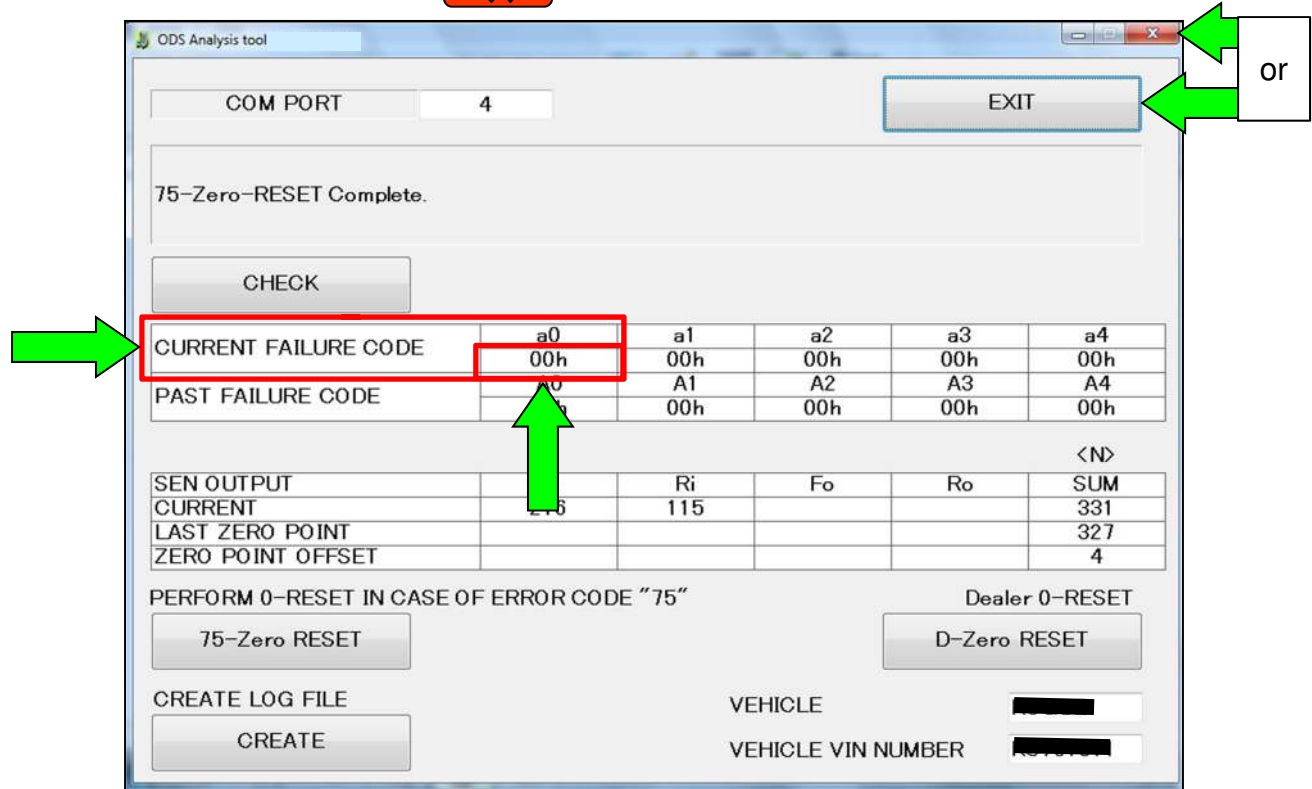
17. When the screen in Figure 10 displays, the 75-Zero reset process is complete.
  - Verify code 75h is not displayed under **CURRENT FAILURE CODE**.
18. Select either **EXIT** or the
