## SERVICE INFORMATION BULLETIN

**APPLICABILITY:** 2012-16MY Impreza  
2012-17MY Crosstrek  
2014-18MY Forester

**NUMBER:** 18-219-22

**SUBJECT:** Service Manual Correction / DTC C2521  
Electric Power Steering (EPS) Motor Malfunction  
and/or DTC 21 Motor Failure 1 (Motor)

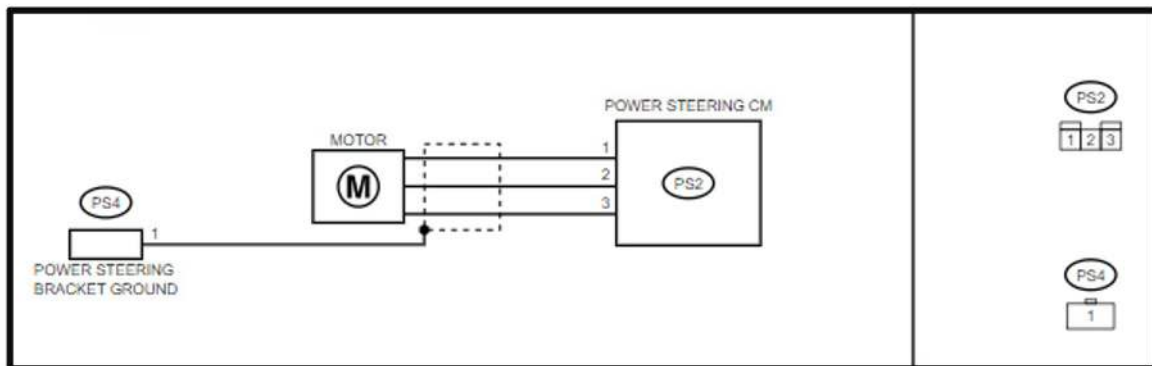
### **DTC C2521 MOTOR MALFUNCTION**

This Service Information Bulletin announces the Service Manual correction for the diagnostic trouble tree for DTC C2521 and/or DTC 21. Added harness testing has been added to the diagnostic steps. If DTC C2521 and/or DTC 21 is detected in the applicable models listed above, follow the new diagnostic information outlined below.
