# Service Bulletin

Bulletin No.: 21-NA-183

**Subject:** Intermittent Door Locks Inoperative, DTCs B3125, B3130, B3135, B3979, B3980, Various U Codes, IP Lamps Illuminate, Immobilizer, Unwanted Horn or Hazard Flasher Operation

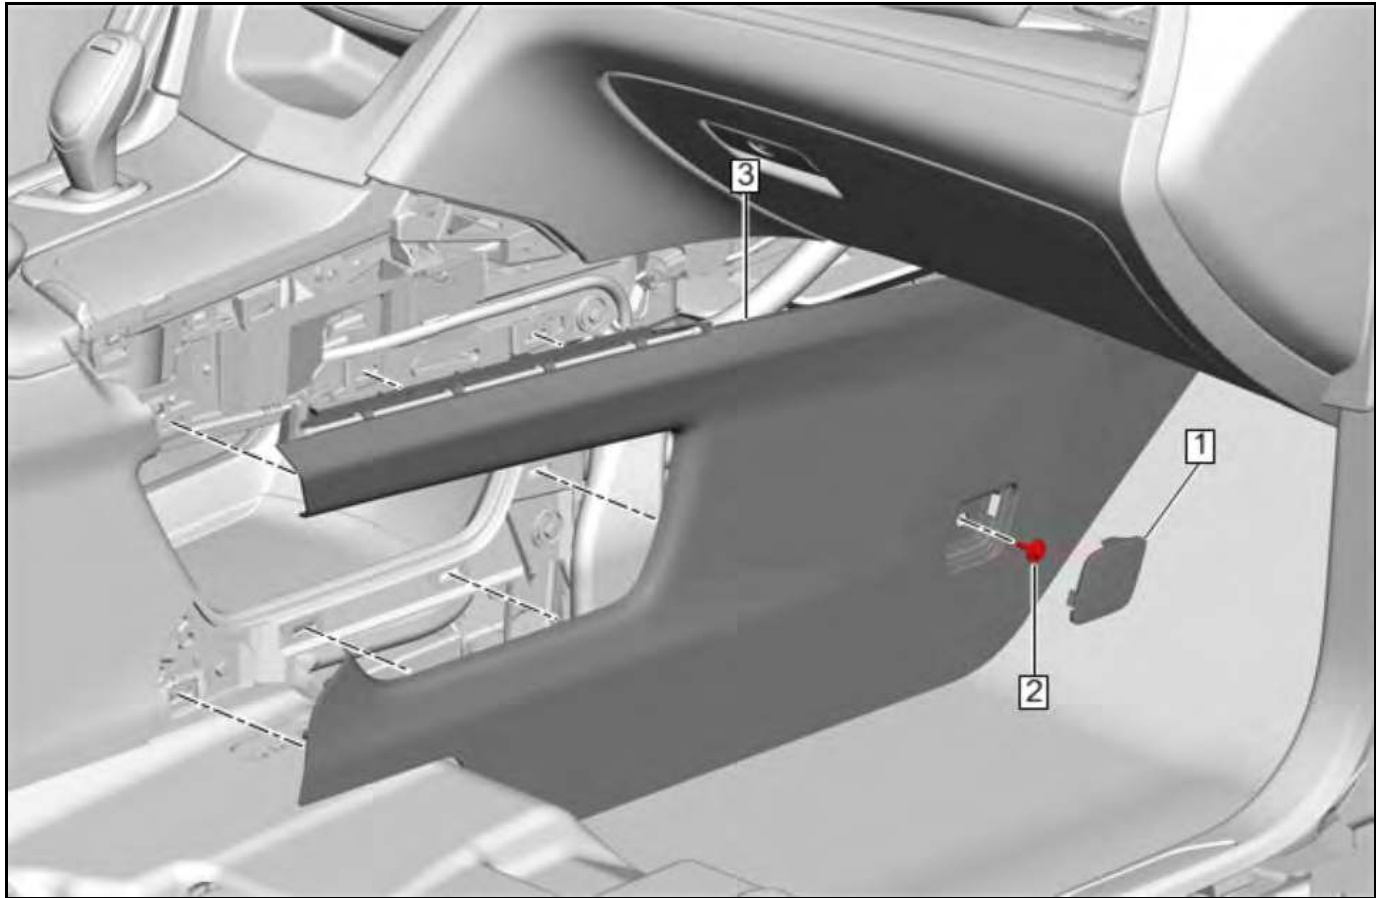
4279414

1. Remove the right front floor console extension panel (3) and inspect for water on the HVAC drain shield, wiring or BCM connectors. Refer to Front Floor Console Extension Panel Replacement - Right Side in SI.

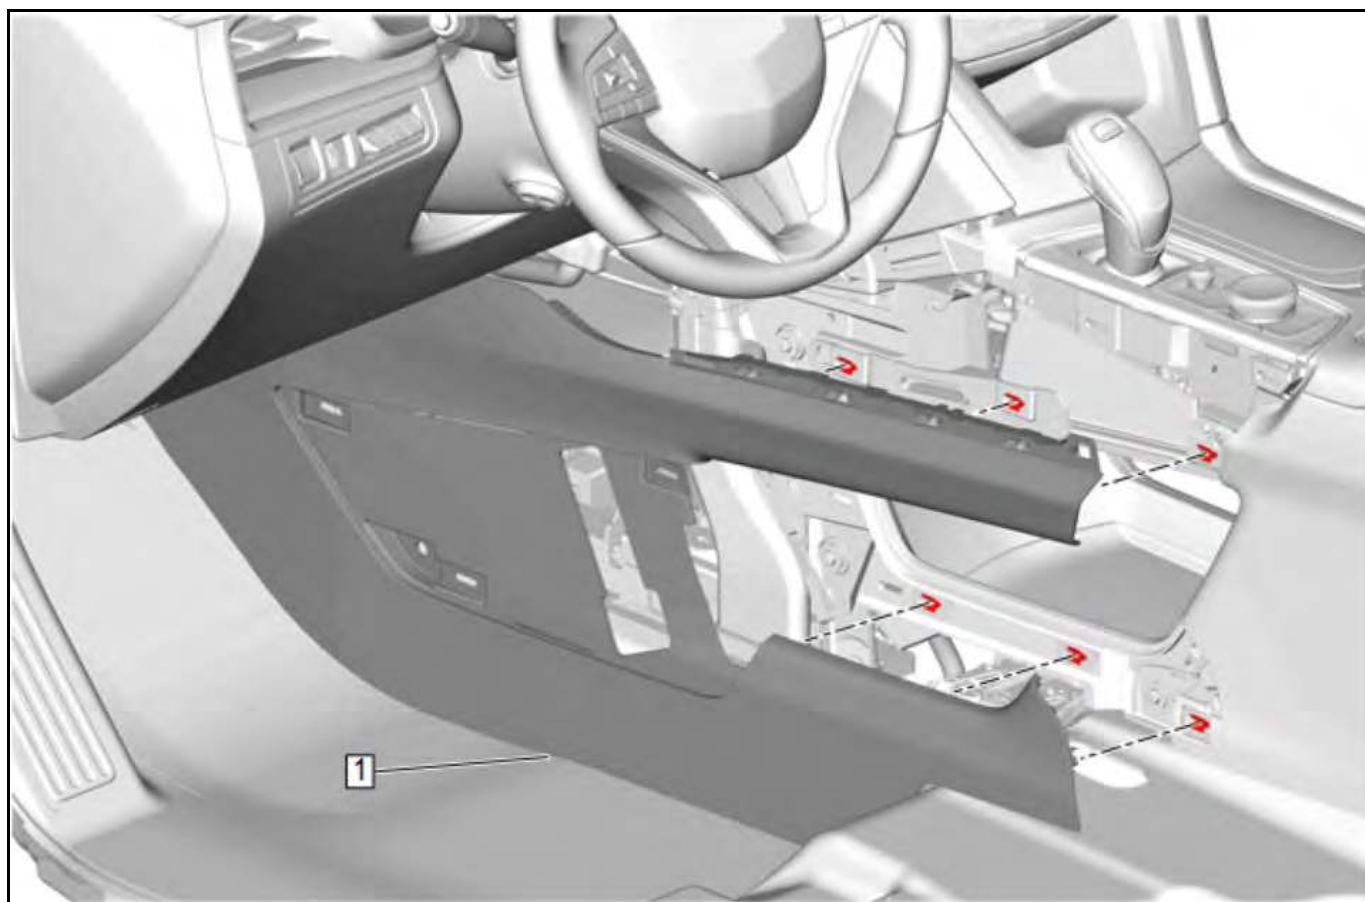
5162610

2. If no water is observed, remove the left-side lower hush panel (if equipped) and the left front floor console extension panel (1). Refer to Front Floor Console Extension Panel Replacement - Left Side in SI.
3. Start the vehicle and turn A/C on Low temp with Blower at maximum speed. Allow the vehicle to run long enough to have water draining out of the drain hose and observe the hose connection to the HVAC module, on both left and right sides, for the appearance of water.
4. If water is seen, please inspect the full length of the hose for kinks.
5. If no kinks are observed, remove the hose from the HVAC module and blow through it to ensure it is clear.
6. Reinstall the hose to the HVAC module, ensuring it is clear and free of kinks.

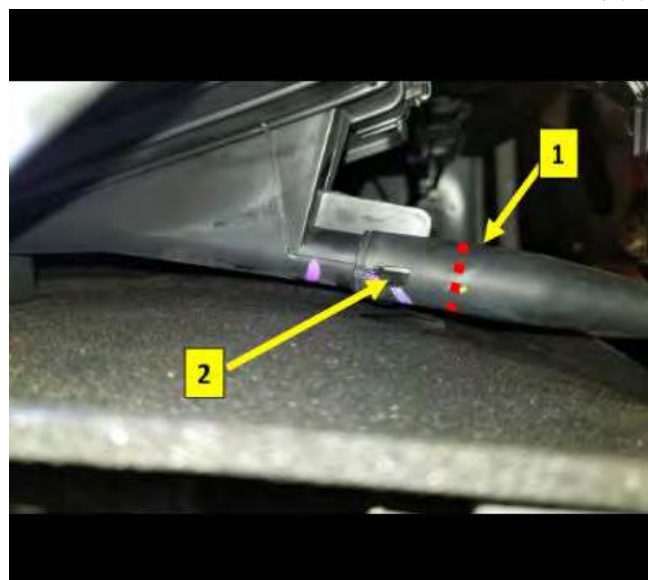
5883903

| Cause | The cause of the condition may be possible water intrusion to the Body Control Module (BCM) from the HVAC drain hose leaking at the connection to the HVAC module. |

Note: Inspect the drain hose connection to the HVAC module. If leaking, water will be seen at the notch in the hose (2), or just above. Addition of a tie strap will prevent further leakage at this connection.

7. Install a tie strap on the drain hose, below the locking nib seen near the top of the drain hose connection to the HVAC module. Install the tie strap where the red dashed line (1) is shown in the graphic above.

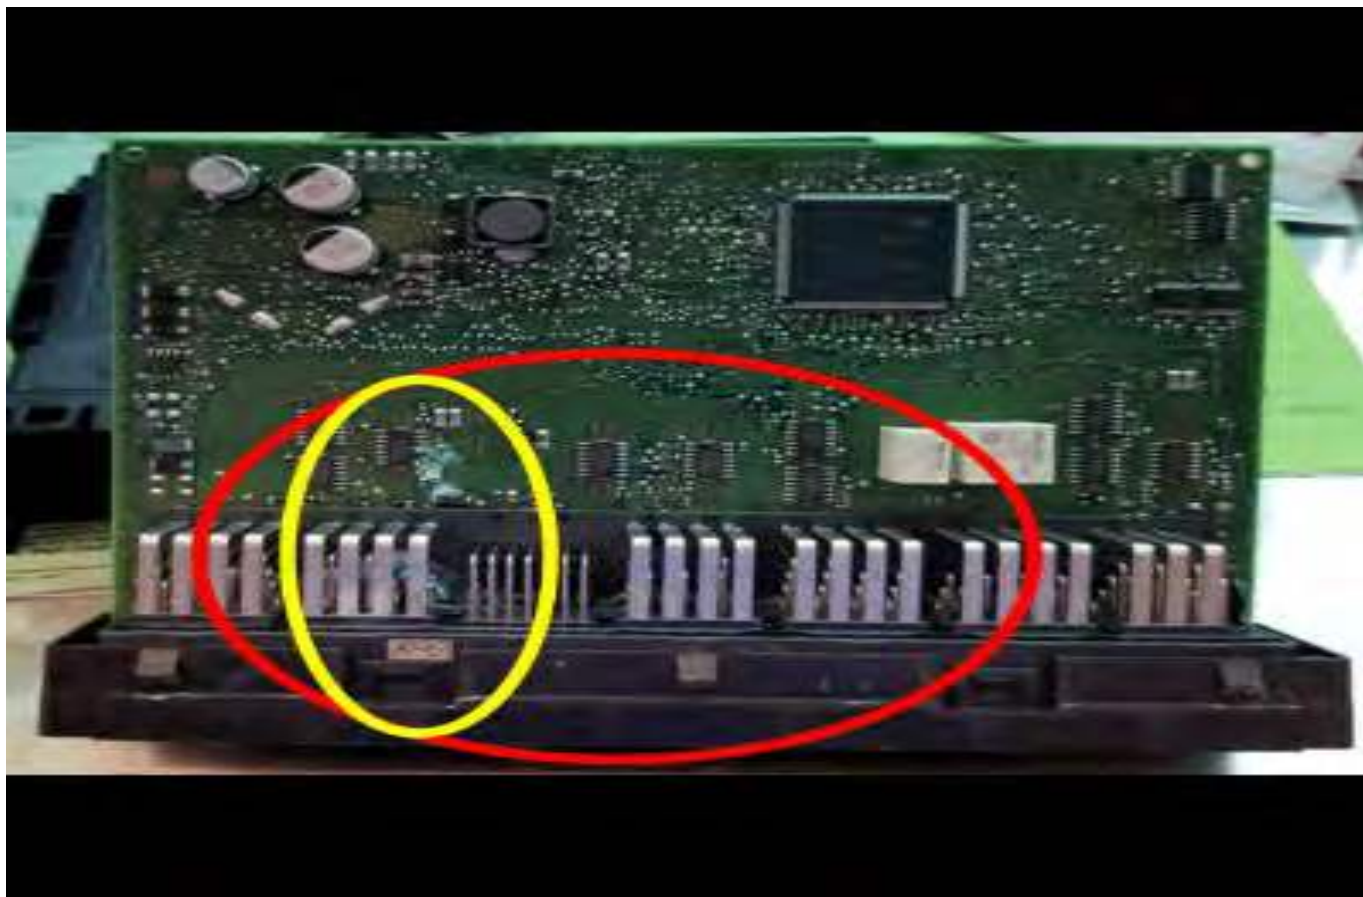
5883904

If water has been leaking from the drain hose, it has most likely entered the BCM. If you see any signs externally, you can verify the need to replace the BCM by disconnecting and removing the BCM, then opening the case. You will see internal damage similar to that shown in the graphic below.

1. Yellow oval highlights corrosion in this BCM.
2. Red oval highlights area to inspect for corrosion.  
Damage internal to the BCM
