| <b>HYUNDAI</b><br><b>Technical Service Bulletin</b> | GROUP<br><b>CAMPAIGN</b> | NUMBER<br><b>22-01-043H</b> |
| | DATE<br><b>MAY 2022</b> | MODEL(S)<br><b>ELANTRA (AD)<br/>KONA (OS)<br/>VELOSTER (JS)</b> |
| <b>SUBJECT:</b> | <b>ENGINE MONITORING LOGIC (SERVICE CAMPAIGN 974)</b> | |

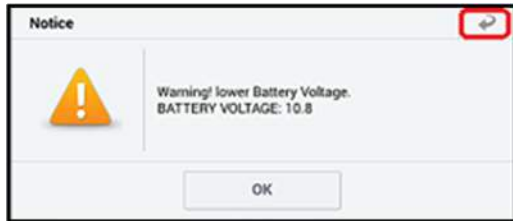
**GDS Vehicle Battery Voltage Warning:**

If voltage is below 12 volts as per the GDS warning, then select **Back** and run the engine at least 15 minutes to reach an adequate battery state of charge to prevent ECU Update failure. Cycle the ignition **OFF/ON** before retrying ECU update again.
