GLOBAL SAFETY FIELD INVESTIGATIONS  
DCS5485  
URGENT - DISTRIBUTE IMMEDIATELY

Subject: A202304840-02 - Service Update  
Camshaft Actuator Oil Control Valve Center Bolt Binding  
Revised parts information and added population.

Models: 2020 – 2021 Buick Encore GX  
2021 Chevrolet Trailblazer  
Equipped with 1.3L Turbo Engine(RPO L3T)

### A202304840 Camshaft Actuator Oil Control Valve Center Bolt Binding

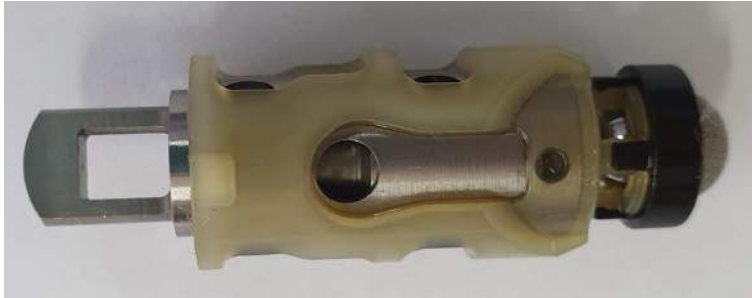
5627952

7. The removed bolt sleeve kit should look as shown – a plastic over molded sleeve.
