# Preliminary Information

## PIC6460 Hood Ajar Message Displayed

| Brand: | Model: | Model Years: | VIN: | | Engine: | Transmissions: |
|---|---|---|---|---|---|---|
| Chevrolet | Impala | 2014 - 2020 | All | All | LKW, LCV | All |

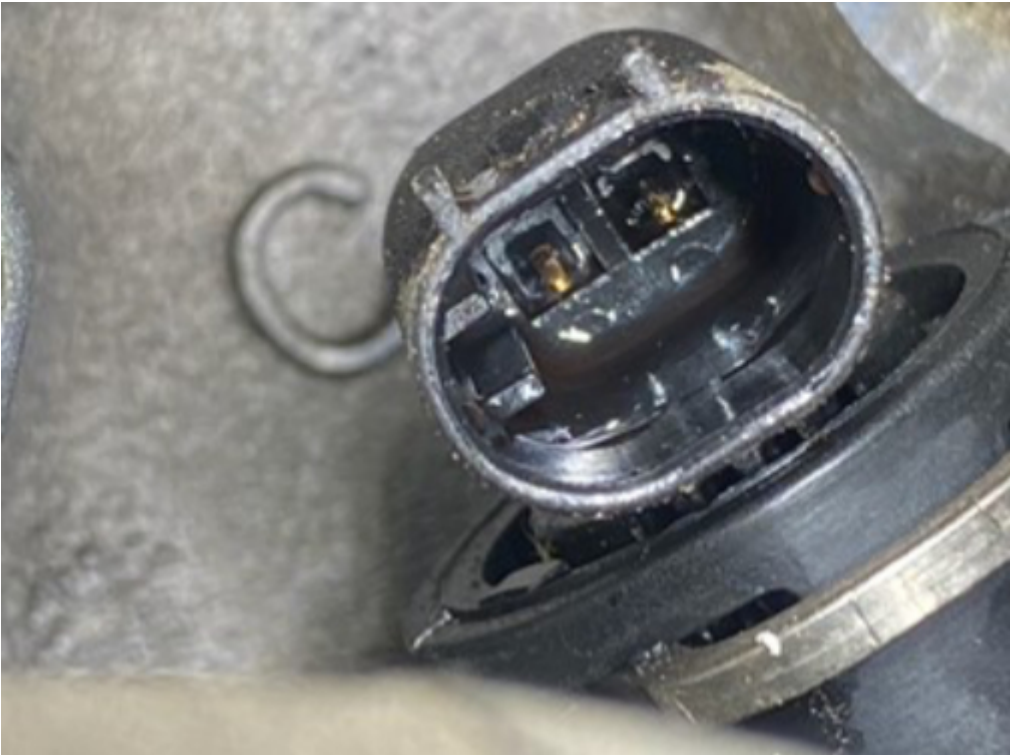
| Cause | Inspect for coolant leaking from the coolant temperature sensor connector wicking up circuits 410 and 2761 from the coolant temp sensor to the ECM connector X3 at Pins 7, 8, 23, and 24. This may cause a short across circuits 5350 and 470 at pins 7 and 23 which is the hood open switch signal and sensor low reference. |

1. Inspect for coolant leaking internally from the ECT sensor by disconnecting the sensor connector.

3. If coolant corrosion or discoloration is found, replace circuits 410 and 2761 from the engine coolant temperature sensor (ECT) to ECM connector X3. Replace the coolant temperature sensor and replace or clean connector X3 at the ECM.

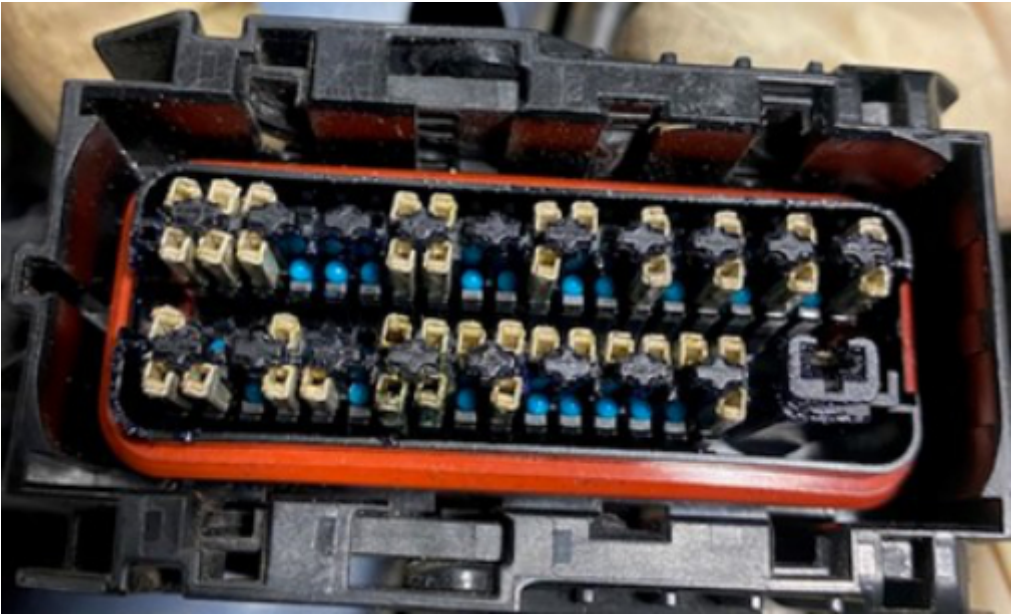
2. Trace the circuits back to the X3 connector at the ECM and inspect for coolant contamination / corrosion.

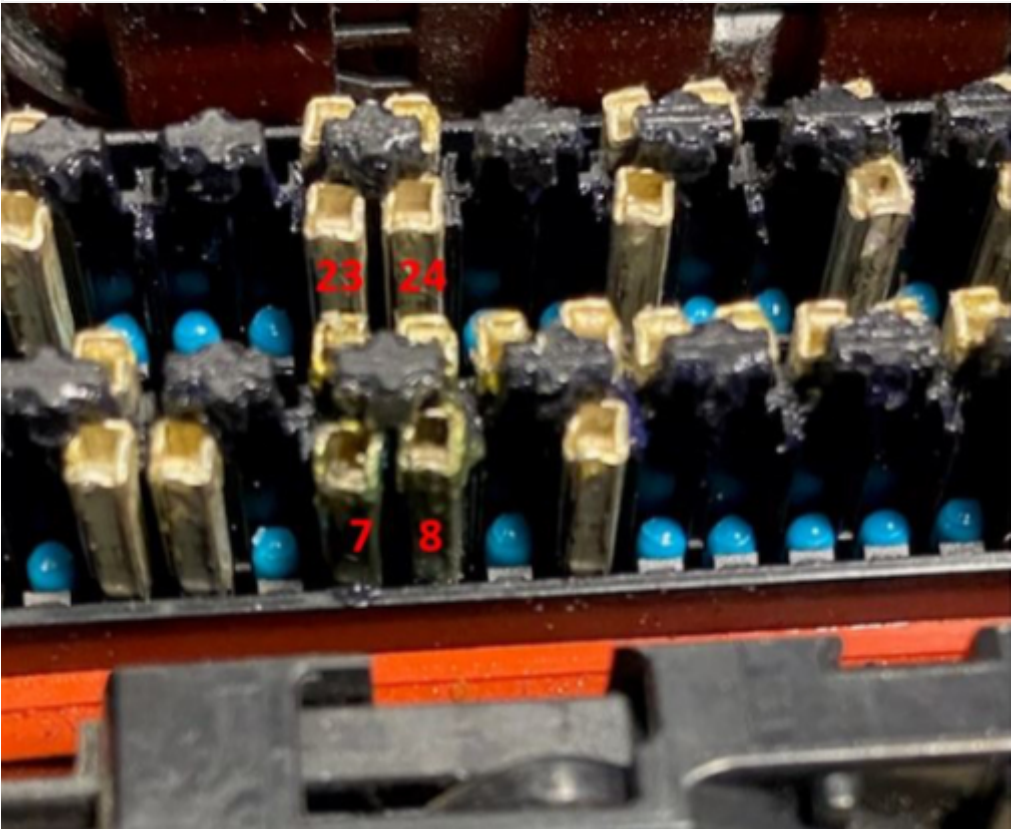
| Pin | Size | Color | Circuit | Function |
|---|---|---|---|---|
| 23 | 0.5 | BK/VT | 470 | Sensor Low Reference |
| 24 | 0.5 | BK/BN | 2761 | Coolant Temperature Sensor Low Reference |
| 7 | 0.5 | YE | 5530 | Hood Open Switch Signal |
| 8 | 0.5 | D-BU | 410 | Engine Coolant Temperature Signal |
