| ELE | 2018-2022MY<br>Stinger (CK) |
| 255 | June 2022 |

## TECHNICAL SERVICE BULLETIN

### DYNAMIC BENDING LIGHT DTC B232509/B232609 - MOISTURE ABSORBENT & BRACKET REPLACEMENT

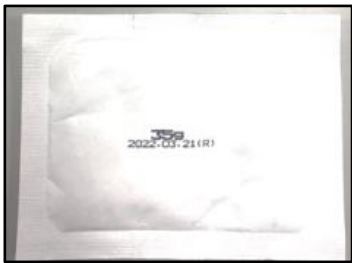
| OLD PARTS | NEW PARTS |
| <p>Bracket (<u>M</u>esh type): 92126 G6000</p> | <p>Bracket (<u>T</u>ension type): 92126 C1500</p> |
| <p>Moisture Absorbent (<u>3</u>5g): 92125 H8350</p> | <p>Moisture Absorbent (<u>2</u>5g): 92125 2W250</p> |

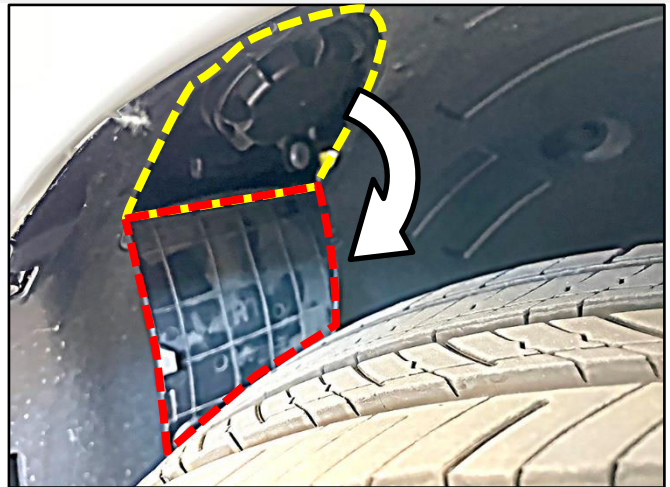
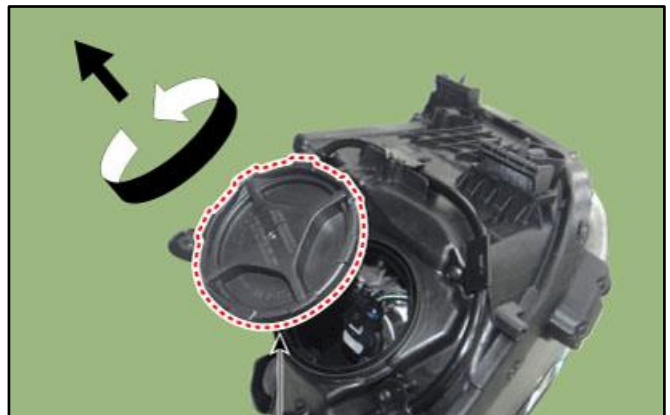
**Note:** The service cover is located on the inner fender liner. Remove the clip at the top of the cover, then fold down as shown to access the dust cover.

Do **NOT** remove the rivets at the bottom of the service cover.

1. Replace the moisture absorbent and bracket on both sides with the new parts by referring to the "Body Electrical System → Lighting System → Headlamps → Repair procedures → Replacement → Moisture Absorbent" chapter in the applicable Shop Manual on KGIS.

Even if only one of the DTCs is found (active or pending), the moisture absorbent and bracket must be replaced on BOTH sides.
