2023MY  
Sportage (NQ5a)

256 (Rev 1, 06/03/2022)

## TECHNICAL SERVICE BULLETIN

SERVICE ACTION: TRANSMISSION WIRE HARNESS  
UPGRADE AND RELATED DTC P07XX, P0880 (SA499)

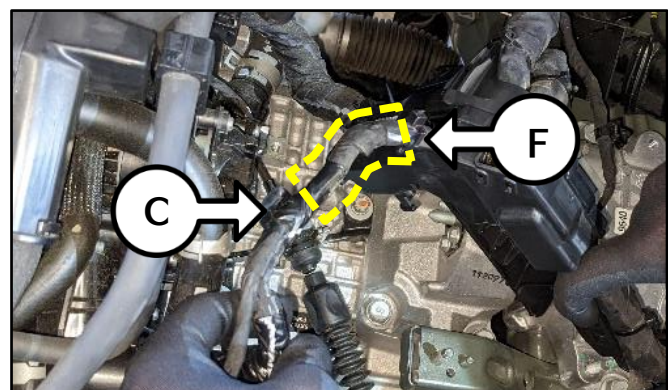
This bulletin provides information to upgrade the transmission wire harness on some 2023MY Sportage (NQ5a) vehicles produced from January 12, 2022 through June 1, 2022, in which the wire harness may rub against the shift cable bracket bolt and in some cases, cause the wiring to become chaffed and create an intermittent ground against the bolt. This condition can potentially cause the MIL to come ON with DTC(s) P07XX and/or P0880 and may cause the vehicle to default into 5th gear. The vehicle can continue to be operated in default mode (5th gear), but it will accelerate slowly. Follow the procedure outlined in this publication to upgrade the transmission harness. Before conducting the procedure, verify that the vehicle is included in the list of affected VINs.

4. Locate the repair area shown between the harness clip (C) and zip tie (F).

If damage to the wire insulation is found, wrap the affected wire(s) with electrical tape prior to continuing with the repair procedure below.
