# Service Bulletin

Bulletin No.: 21-NA-024

Subject: Service Engine Soon MIL Illuminated with DTC P2B87 Set

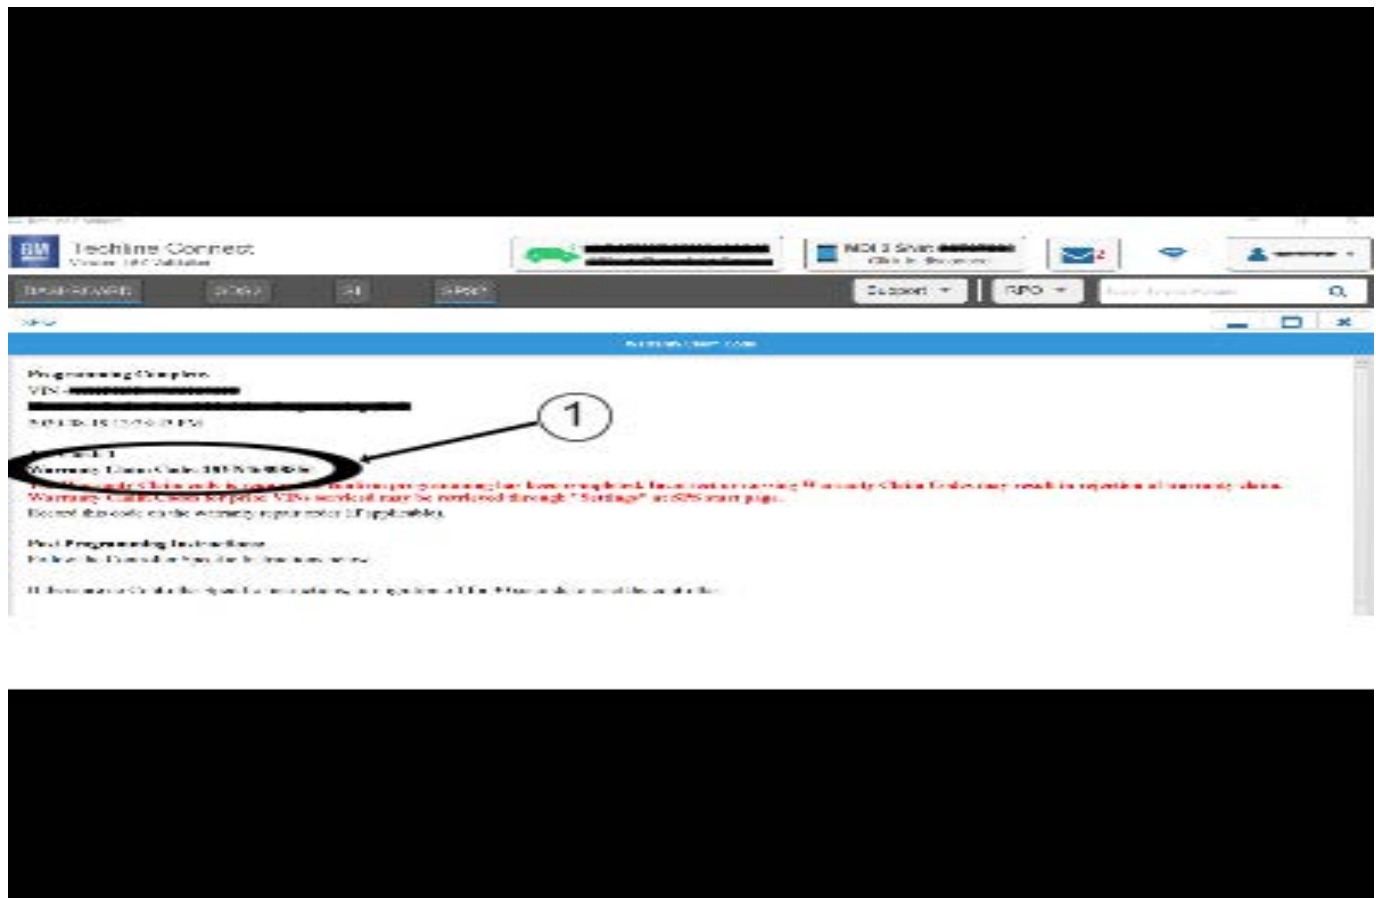
5644478

Important: To avoid warranty transaction rejections, you MUST record the warranty claim code provided on the Warranty Claim Code (WCC) screen shown above on the job card. Refer to callout 1 above for the location of the WCC on the screen.

- 2. Record Warranty Claim Code on job card for warranty transaction submission.
