# Service Bulletin

Bulletin No.: 21-NA-246

Subject: Unwanted Front Windshield Wiper Swipe, Cruise Control Will Not Turn On, Steering Wheel Controls Inoperative, DTCs P155A/00, B1529/03

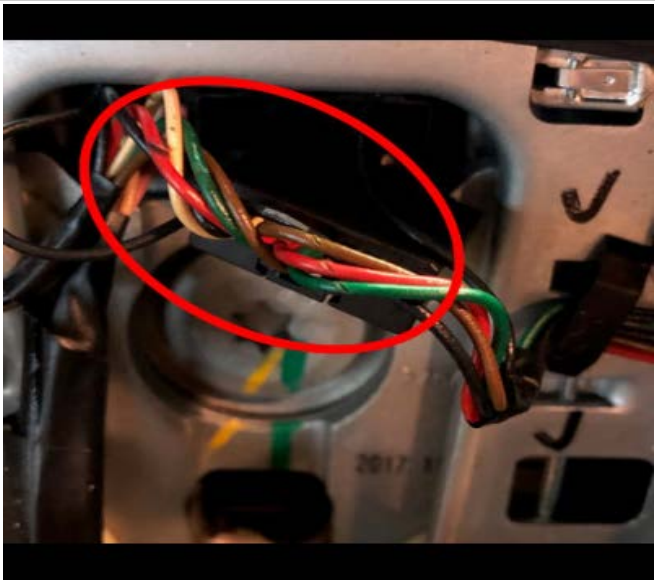
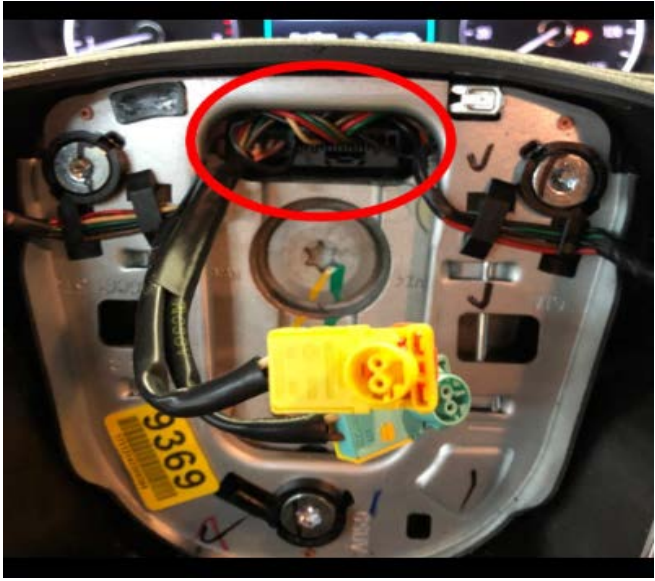
| <p>Cause</p> | <div data-bbox="683 153 1333 728"></div> <div data-bbox="1419 739 1481 758"><p>5480325</p></div> <div data-bbox="683 774 1333 1350"></div> <div data-bbox="1419 1358 1481 1377"><p>5480327</p></div> <p>The cause of the condition may be the steering wheel harness shorted under the steering wheel inflator module.</p> |

| <p>Correction</p> | <p>If you encounter a vehicle with the above concern, inspect and repair the steering wheel harness referring to the proper wire repair procedures. Refer to Wire to Wire Repair in SI.</p> |
