# Service Bulletin

Bulletin No.: 21-NA-192

**Subject:** Convertible Top May Not Lower Intermittently, DTC B19E4 SYM64 May be Stored in History

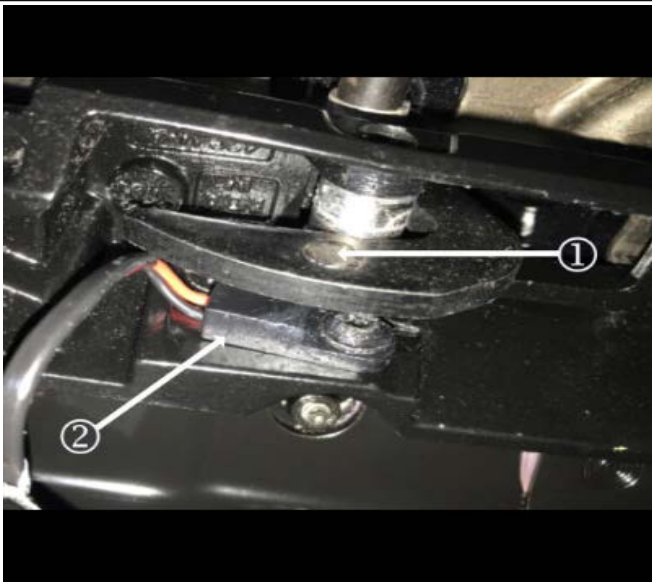
| Cause | <p>5892481</p> <p>Note: This hall effect sensor (2) is looking for the roof to be fully latched at the header. We have seen cases where the hook is not extending far enough to reach the magnet (1). The cause of the condition may be that the hall effect sensor, in the right side folding top front latch striker, may be out of position.</p> |

| Correction | The simplest solution is to adjust the right side folding top front latch striker following the steps in the Service Procedure below. |
