# MIL ON With DTCs P0AA649 and/or P1C8049 or AM Radio Static/Distortion

**Service Category** Engine/Hybrid System

**Section** Hybrid/Battery Control System

| YEAR(S) | MODEL(S) | ADDITIONAL INFORMATION |
|---|---|---|
| 2019 - 2021 | RAV4 HV | VDS(s): BWRFBV, D6RFBV, DWRFBV, E6RFBV, EWRFBV, L6RFBV, LWRFBV, M6RFBV, MWRFBV, R6RFBV, RWRFBV |

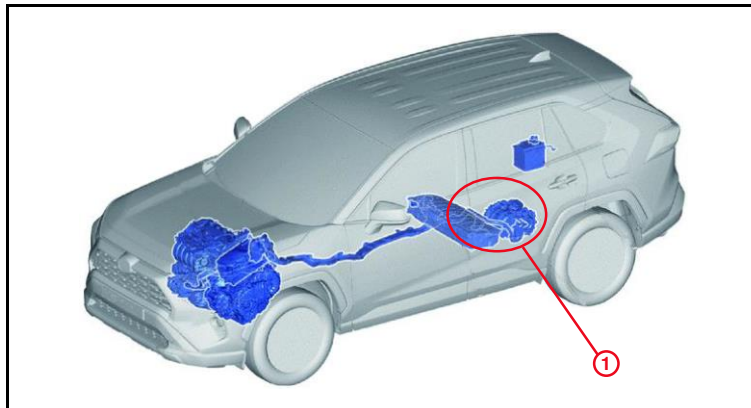
**Figure 1. Image of HV Floor Under Wire Pathway Through Vehicle**

The vehicle may also exhibit static or distortion when listening to AM radio. These conditions may be caused by corrosion on the high-voltage wire harness below the vehicle at connector Y6 at Motor Generator Rear (MGR) or dirt and debris inside the connector. Follow the Repair Procedure in this bulletin to address these conditions.

| <b>1</b> | <b>Area of Concern</b> |

4. Replace the HV Floor Under Wire.

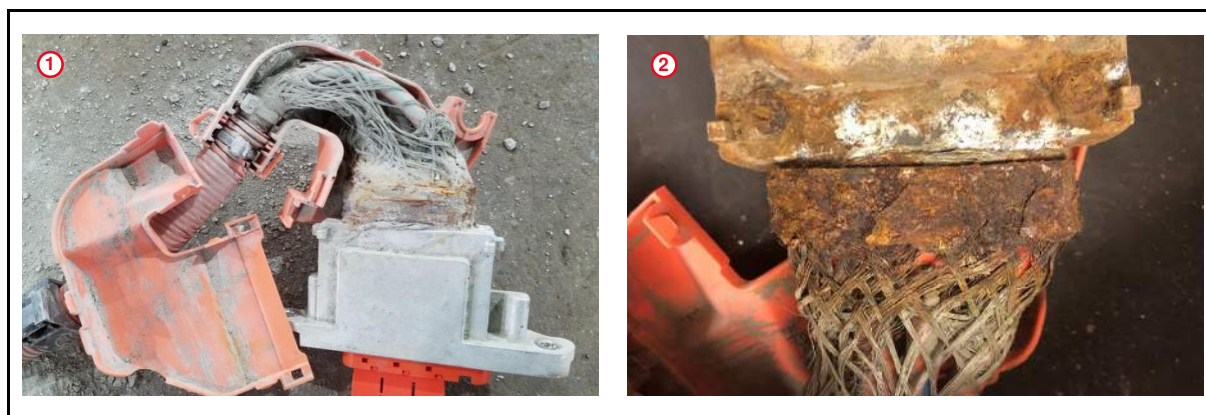
**Figure 2.**

| 1 | Dirt, Corrosion, and Debris Build-up |
| 2 | Corrosion |

- B. Disconnect the Y6 connector at the MGR and inspect for corrosion, dirt, or debris. Is dirt, debris, or corrosion present?
      - **YES** — Continue to step 2.
      - **NO** — This bulletin does NOT apply. Continue diagnosis using the applicable Repair Manual.

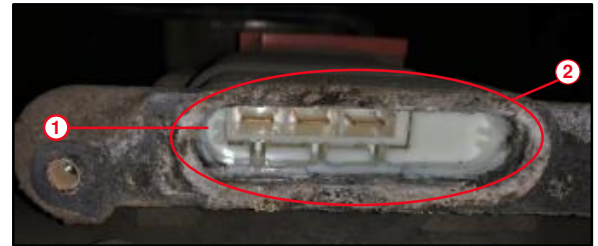
**Figure 3.**

2. Check connector housing of the MGR.  
Is the chamfer or a further inner part corroded as shown?
  - **YES** — Continue to step 3.
  - **NO** — Go to step 4.

| 1 | Chamfer |
| 2 | Corrosion |

3. Replace the Cable, Motor, No. 2.
  - A. Remove Cable, Motor, No. 2 rear traction motor.  
Refer to TIS, applicable model and model year Repair Manual:
    - [2019](#) / [2020](#) / [2021](#) RAV4 HV:

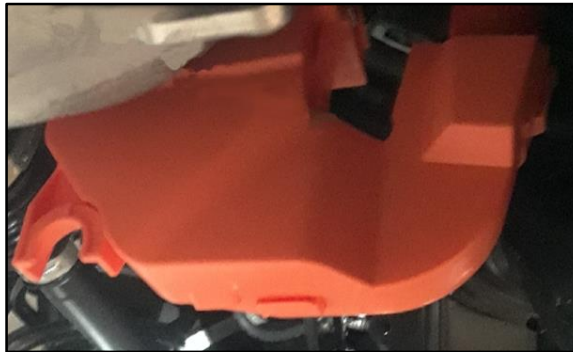
**Figure 4. Original Part Installed**

As shown in Figure 5, the HV Floor Under Wire may have a different appearance than the original part, shown in Figure 4. This is a normal condition.
