## STAR ONLINE PUBLICATION

**Case Number:** S1925000008 REV. D

**Symptom/Vehicle Issue:** Malfunction Indicator Lamp (MIL) Illumination. Diagnostic Trouble Codes (DTCs) P208B – Reductant Pump 1 Control Performance, and/or P20E8 – Reductant Pressure Too Low, Set.

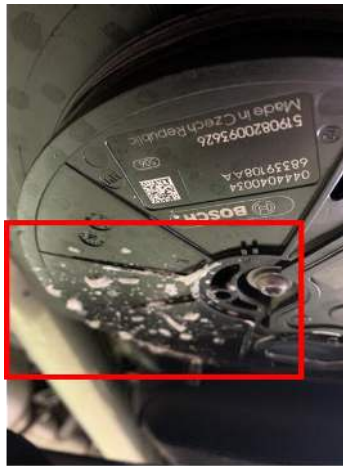
Figure 1.

2. Closely inspect the DEF supply line connections at the pump and injector to ensure there are no leaks. Look for signs of wetness, and/or crystallization around the connections indicating a leak. Please see (Figure 1, and 2.). Repair any leaks before proceeding with the rest of this procedure.
