**NUMBER:** 18-056-22 REV. A

Flash: Powertrain Control Module (PCM) Updates

This bulletin involves reprogramming the Engine Control Module/Powertrain Control Module (ECM/PCM) with the latest available software.

**NOTE: This bulletin applies to vehicles equipped with a 6.7L I6 Cummins Turbo Diesel Engine (Sales Code ETN).**

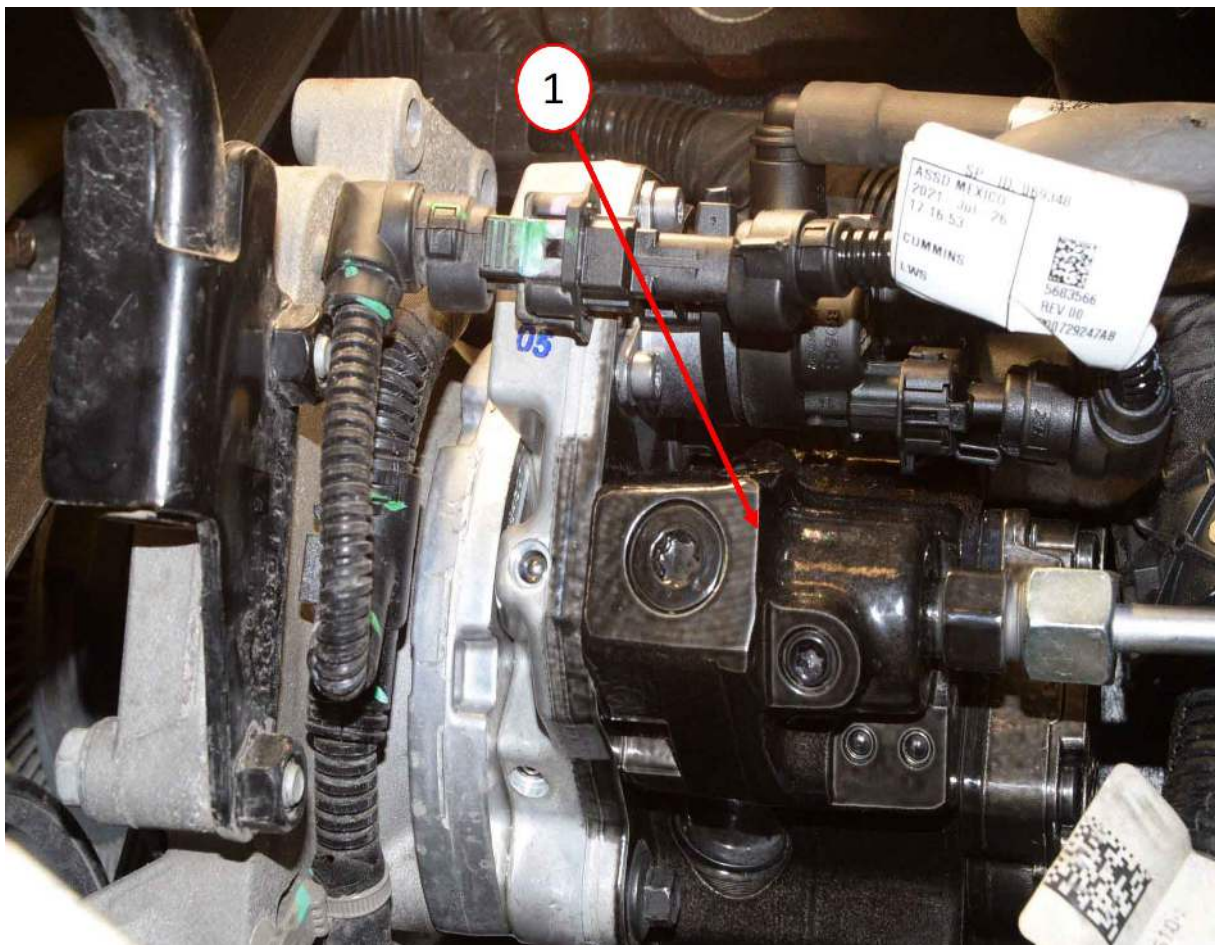
**Fig. 1**  
**CP3.3 Design Pump**

**NOTE:** The only calibration available will be for the updated CP3.3 design High-Pressure Fuel Injection Pump (Fig. 1) . Please ensure that recall Y78 has been completed first before proceeding with this update.

1. Inspect the High-Pressure Fuel Injection Pump to see which pump is currently installed on the vehicle (Fig. 1) . Also review the vehicle VIP report to see if campaign Y78 has been performed.

2. Does the VIP report indicate that Y78 has been performed, and is the vehicle equipped with the new design fuel injection pump released under the campaign?
  - YES>>> Proceed to [Step 1](#).
  - NO>>> Perform the Y78 campaign first. Once the campaign is performed, new pump installed and PCM updated, the PCM will have all of the updates listed in this document. This Bulletin does not apply.
