**NUMBER:** 18-101-22

**GROUP:** 18 - Vehicle Performance

Flash: Powertrain Control Module (PCM) Updates

This bulletin involves reprogramming the Engine Control Module (ECM) / Powertrain Control Module (PCM) with the latest available software.

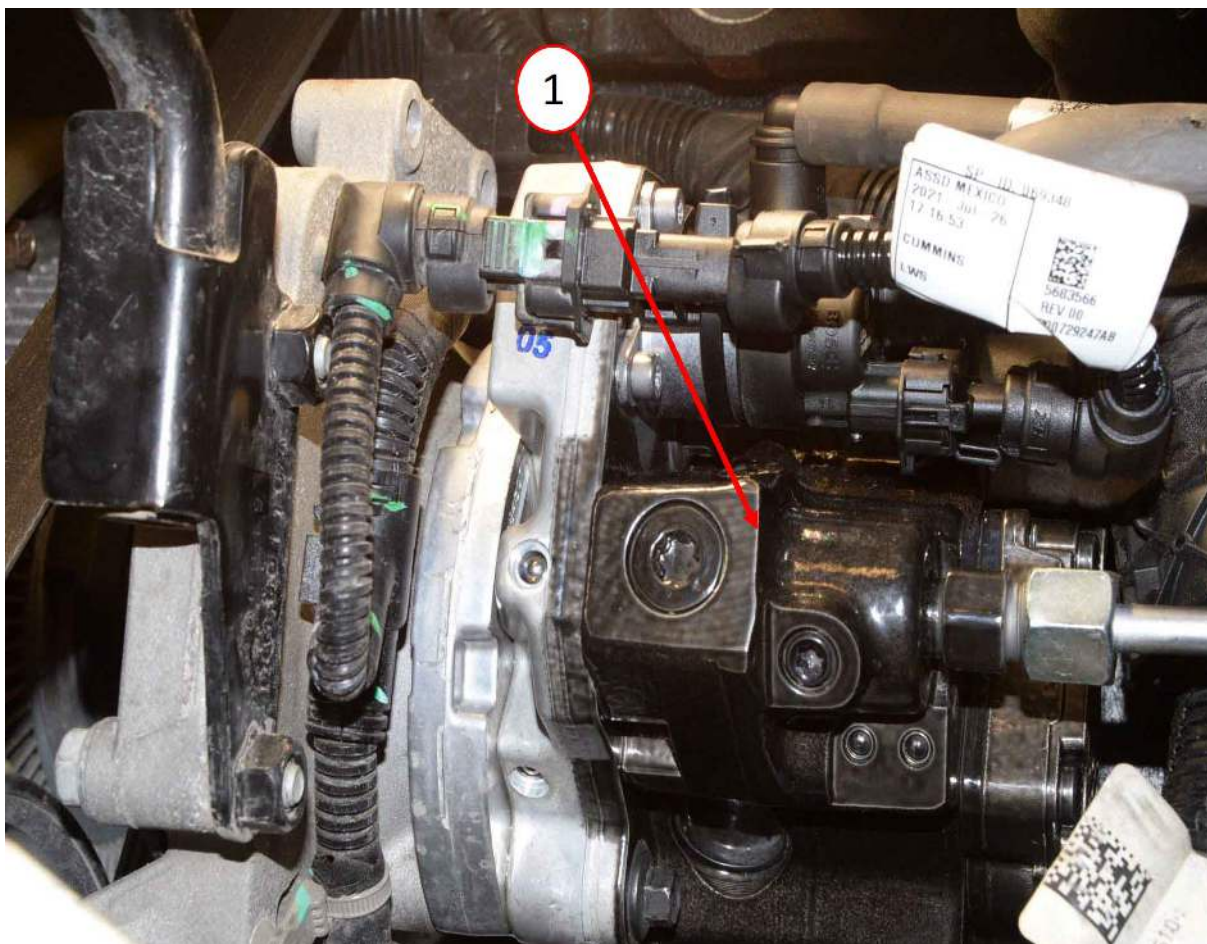
**Fig. 1**  
**CP3.3 Design Pump**

**NOTE:** \*\*The only calibration available will be for the updated CP3.3 design High-Pressure Fuel Injection Pump ([Fig. 1](#)) . Please ensure that recall Y78 has been completed first before proceeding with this update.

1. Inspect the High-Pressure Fuel Injection Pump to see which pump is currently installed on the vehicle ([Fig. 1](#)) . Also review the vehicle VIP report to see if campaign Y78 has been performed.

1 - CP3.3 Design Pump From Top View.

2. Does the VIP report indicate that Y78 has been performed, and is the vehicle equipped with the new design fuel injection pump released under the campaign?
  - YES>>> Proceed to [Step 1](#).
  - NO>>> Perform the Y78 campaign first. Once the campaign is performed, new pump installed and PCM updated, the PCM will have all of the updates listed in this document. This Bulletin does not apply.\*\*
