**NUMBER:** 18-102-22

**DATE:** May 24, 2022

Flash: Powertrain Control Module (PCM) Updates

This bulletin involves reprogramming the Engine Control Module/Powertrain Control Module (ECM/PCM) with the latest available software.

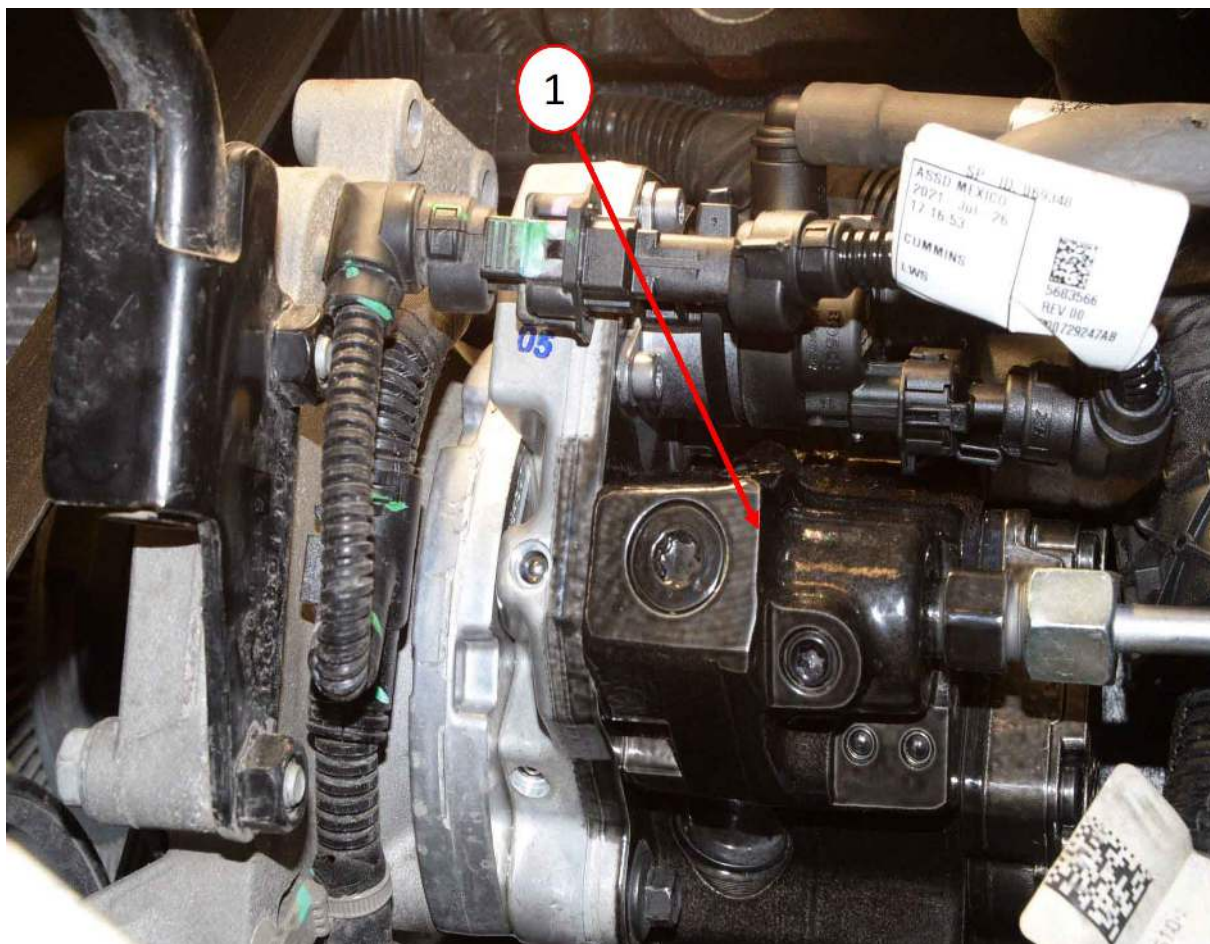
**Fig. 1**  
**CP3.3 Design Pump**

**NOTE:** \*\*The only calibration available will be for the updated CP3.3 design High-Pressure Fuel Injection Pump (Fig. 1) . Please ensure that recall Y78 has been completed first before proceeding with this update.

1. Inspect the High-Pressure Fuel Injection Pump to see which pump is currently installed on the vehicle (Fig. 1) . Also review the vehicle VIP report to see if campaign Y78 has been performed.

1 - CP3.3 Design Pump From Top View.

2. Does the VIP report indicate that Y78 has been performed, and is the vehicle equipped with the new design fuel injection pump released under the campaign?
  - YES>>> Proceed to [Step 1](#).
  - NO>>> Perform the Y78 campaign first. Once the campaign is performed, new pump installed and PCM updated, the PCM will have all of the updates listed in this document. This Bulletin does not apply.\*\*
