**NUMBER:** 18-055-22 REV. A

Flash: Powertrain Control Module (PCM) Updates

This bulletin involves reprogramming the Engine Control Module (ECM) / Powertrain Control Module (PCM) with the latest available software.

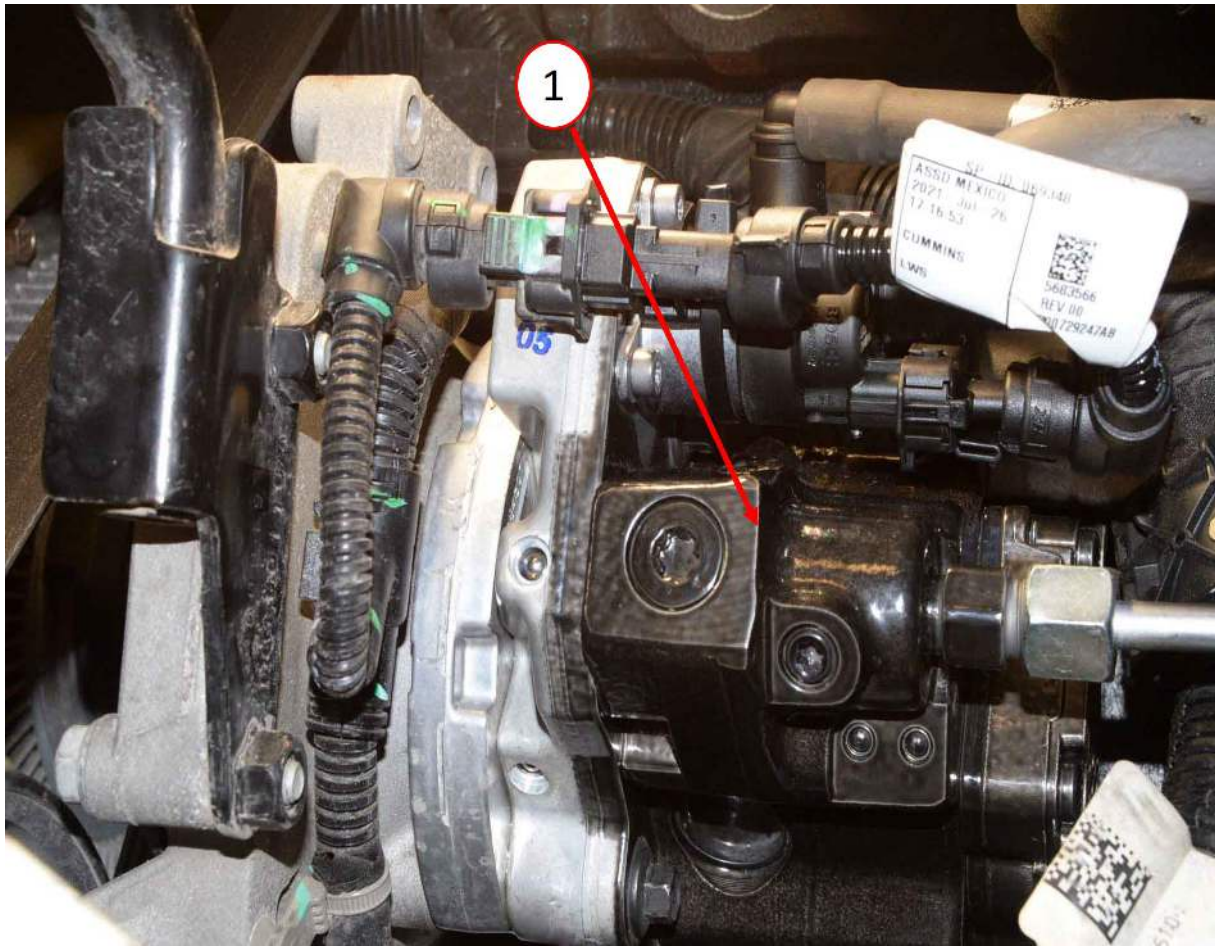
**Fig. 1**  
**CP3.3 Design Pump**

**NOTE: The only calibration available will be for the updated CP3.3 design High-Pressure Fuel Injection Pump (Fig. 1) . Please ensure that recall Y78 has been completed first before proceeding with this update.**

1. Inspect the High-Pressure Fuel Injection Pump to see which pump is currently installed on the vehicle (Fig. 1) . Also review the vehicle VIP report to see if campaign Y78 has been performed.

1 - CP3.3 Design Pump From Top View.

2. Does the VIP report indicate that Y78 has been performed, and is the vehicle equipped with the new design fuel injection pump released under the campaign?
  - YES>>> Proceed to [Step 1](#).
  - NO>>> Perform the Y78 campaign first. Once the campaign is performed, new pump installed and PCM updated, the PCM will have all of the updates listed in this document. This Bulletin does not apply.
