# Technical Service Bulletin

90 Audi connect user management option greyed out or SOS and Roadside with no function (DTC P169A00 / U13EB00)

90 22 73 2052299/5 June 29, 2022. Supersedes Technical Service Bulletin Group 90 number 22-46 dated February 22, 2022 for reasons listed below.

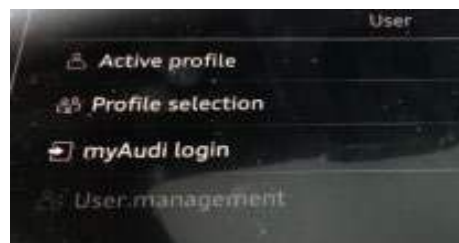
- The Audi Connect “User management” screen is greyed out and the customer cannot complete the key user pairing (Figure 1).

*Figure 1. User management.*

1. Change the adaptation for flight mode in diagnostic address 0075 at, *Self-diagnosis >> Go to address 0075 >> Adaptation values “Basis connect function” >> Flight mode >> Deactivate.*

2. Hit "Apply".
3. Cycle the ignition off and then back on.
4. Within Self-diagnosis go to DTC readout for diagnostic address 00175 and clear the DTC.
5. Cycle the ignition off and then back on again.
6. Verify that the SOS light is green and/or the Audi connect User management option is now selectable.
7. If the issue persists disconnect the tester, roll the windows up, close all doors, and lock the vehicle for 2-3 minutes to allow the car to go through a sleep cycle, then retry steps 4-6 if necessary.

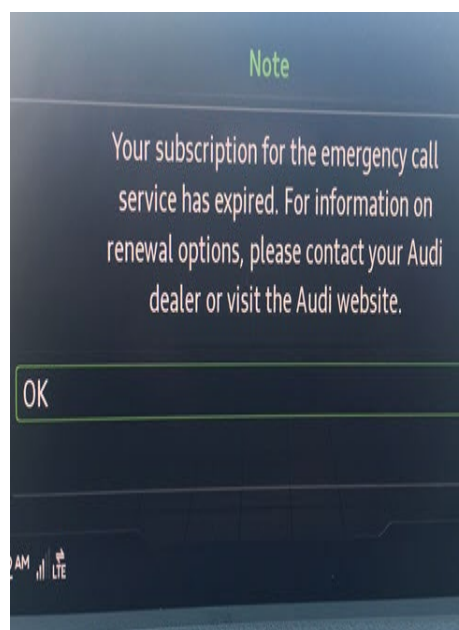
- The SOS emergency button is red or flashing red. When the customer presses the button, the message “Your subscription for the emergency call service has expired. For information on renewal options, please contact your Audi dealer or visit the Audi Website” (Figure 2) is displayed.

*Figure 2. Error message in MMI.*
