# Technical product information

| Topic | Warning evident within the DIP for the steering system - DTC U103100 evident within diagnostic address 0044 |
| Brand | Bentley |
| Transaction No. | 2067399/1 |

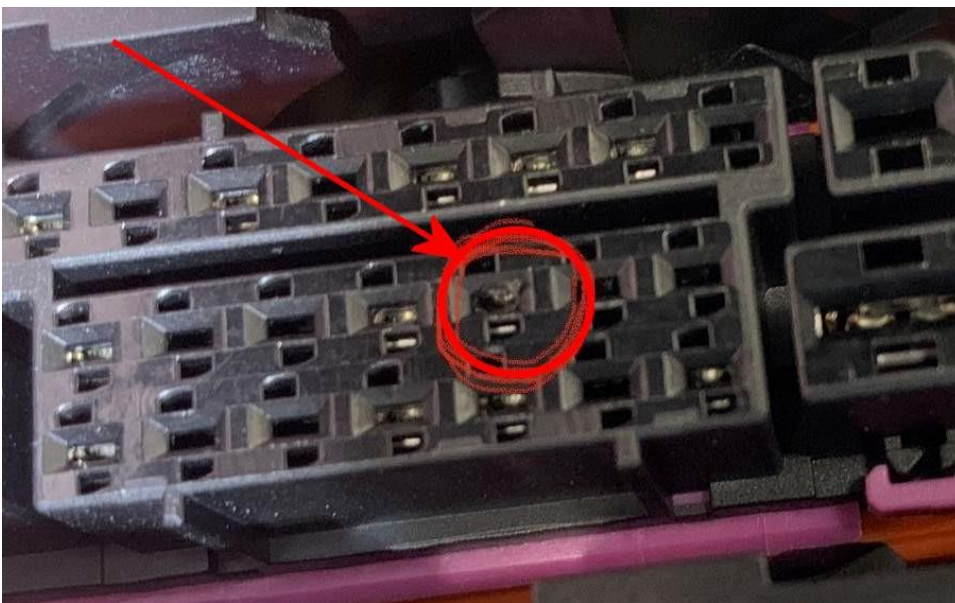
- Referring to the applicable wiring diagram - Conduct a visual check of plug connection for J539, the example in Figure 1 shows damage to pin 14 (Brake servo control unit)

- Referring to Rep.Gr 97 - Conduct any applicable wiring repairs
