# Technical Service Bulletin

CHECK ENGINE LIGHT ON WITH DTCs P24C6:00, P24C7:00,  
P24AE:00, P24B1:00 AND/OR P24AF:00

Bulletin No.: 01-005/22

2018-2019 CX-5 SKYACTIV-D 2.2

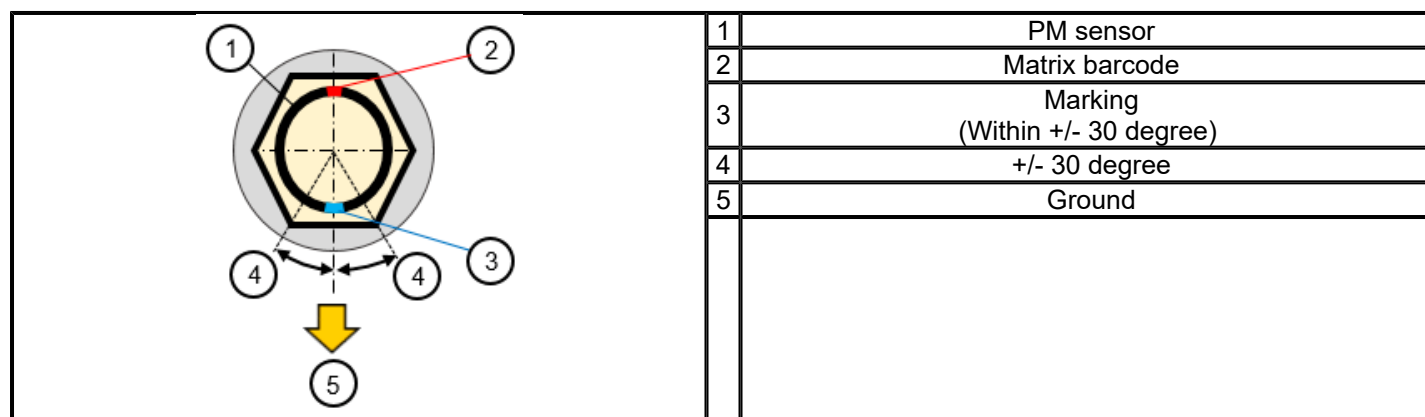
**NOTE:** To reduce water accumulation in the PM sensor, follow the steps below when installing the sensor so the sensor element faces upward.

1. Find the matrix barcode (2) on the PM sensor (1) that faces the same direction as the sensor element (See "Location of matrix barcode" below).
2. Mark (3) the sensor body 180 degrees opposite of the matrix barcode and harness side of the free nut.
3. Install the PM sensor so that the marking faces downward to the ground (5) +/- 30 degrees (4).

**NOTE:** When tightening the free nut, the sensor housing may turn together. For the best result, temporarily tighten the nut holding the sensor housing at 15 degrees before the target angle, then tighten to the specified torque.

- Tightening torque: 30-44 ft·lbf {40-60 N·m, 4.1-6.1 kgf·m}

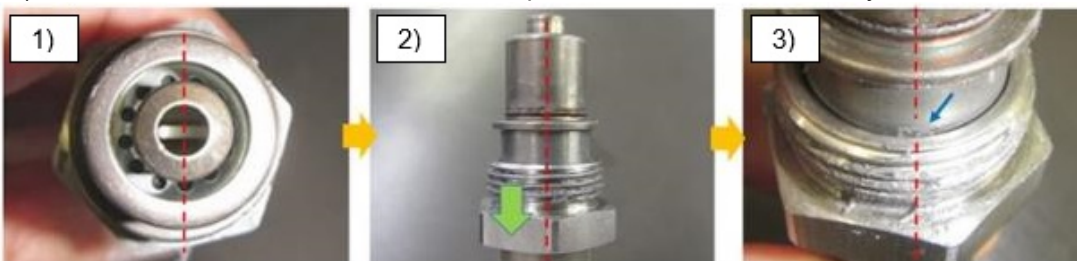
**Procedure (A)** Looking from the sensor element side:

**NOTE:** If the matrix barcode is not found, it may be hidden under the free nut. This may be due to a variation in manufacturing.

- 1) Locate the sensor element plate.
- 2) Push the free nut downward.
- 3) Hold the nut to create clearance, then inspect the area shown below by the arrow.

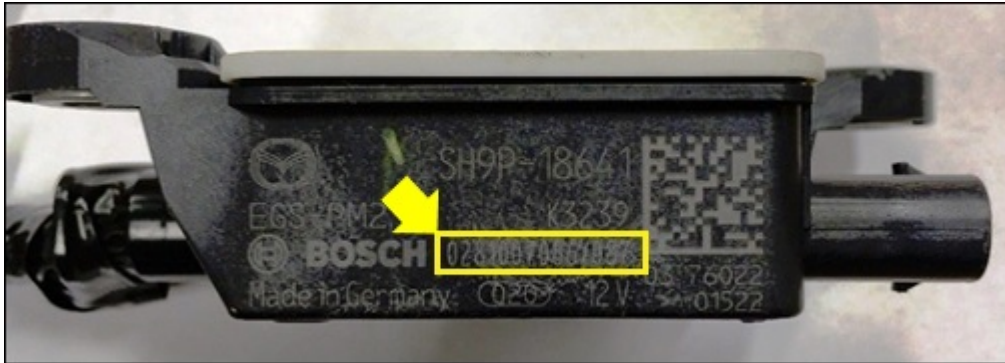
**NOTE:** If the modified parts kit listed in the table above is not available, an older parts kit (SHY6-18-7E0A) may be ok to use for this repair. Follow the sensor inspection instructions below to determine if the older kit can be used for this repair or not.

1. Inspect the ID Number (shown below) on the PM sensor from kit SH9P-18-641A.
2. Is the ID Number **0281007918/919** or greater?

- If No, the kit cannot be used in this repair.
- If Yes, the kit can be used in this repair.
