## Technical product information

| <b>Topic</b> | DTC B17B801 and/or B17B804 - evident within address 0019 and/or DTC U112300 evident in 00A5 |
| <b>Brand</b> | Bentley |
| <b>Transaction No.</b> | 2063855/4 |

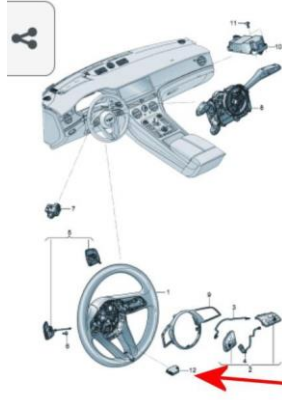
TPI 2063855/4 - Additional request to replace the control module (as Figure 1) in conjunction with the steering wheel

IMPORTANT: The operative must also replace the control module shown in Figure 1

2) Conduct a visual check between the original steering wheel and the replacement steering wheel to confirm all applicable components have been transferred successfully and control module replaced as shown in Figure 1

**IMPORTANT:** The operative must also replace the control module shown in Figure 1 - Refer to the ETKA parts catalogue
