## Technical product information

| <b>Topic</b> | Bentayga and New Flying Spur Hybrid– DTC P103A00 evident – Engine Oil Fuel Portion Too High |
| <b>Transaction No.</b> | 2062365/2 |

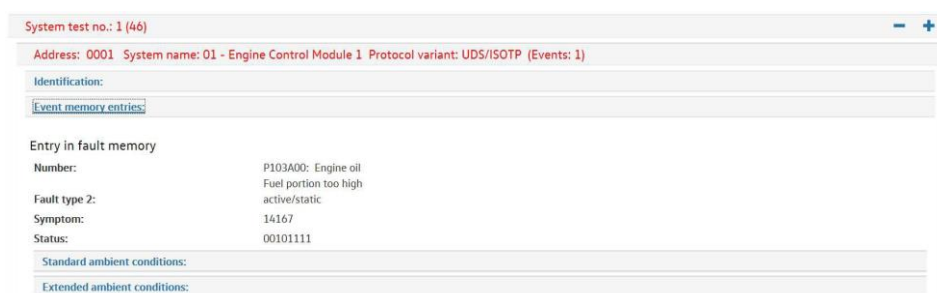
Figure 2

- DTC P103A00 evident - Engine Oil Fuel Portion Too High (Figure 2)

- Smell of fuel in the engine oil

When the fuel calculation reaches the pre-programmed amount this then causes the DTC to be triggered

3) Drive the vehicle in SPORT mode for 30 KM (*Observing all local speed limits*) with enthusiastic driving to reduce the fuel MWB value (IDE04820) to less than 50 grams

- In the event the MWB value (IDE04820) has been successfully reduced (Lower than 50 grams) Erase the applicable DTC's
