# Technical product information

| Topic | HV battery will not charge - DTC's stored in address 19 (C11C5F2) and address C6 (P0D6D00) for the High Voltage System |

## New Flying Spur Hybrid

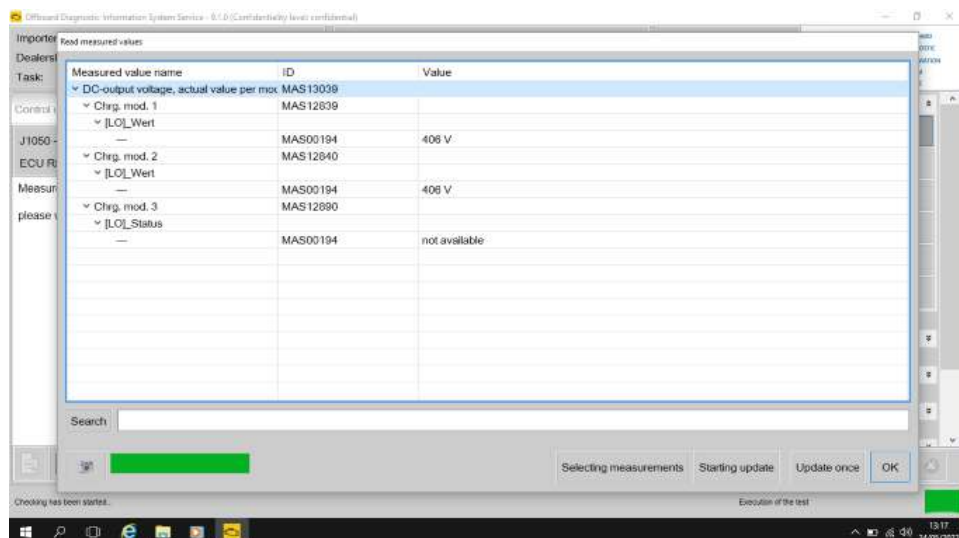
Internal harness failure of the High Voltage cable between the HV battery and the On-board charger

Select – 'MAS 13039 DC–Output voltage, actual value per module'

If both values read 0V then the High Voltage cable between the HV battery and the On-Board Charger must be replaced

4) Replace the High Voltage cable between the HV battery and the On-Board Charger

7) Repeat step 2, the voltages should now read HV Battery Voltage (approximately 400V)
