# Service Bulletin

Bulletin No.: 22-NA-130

Subject: "Service Instrument Cluster" Lamp Illuminated on the DIC with DTC U3000 Set

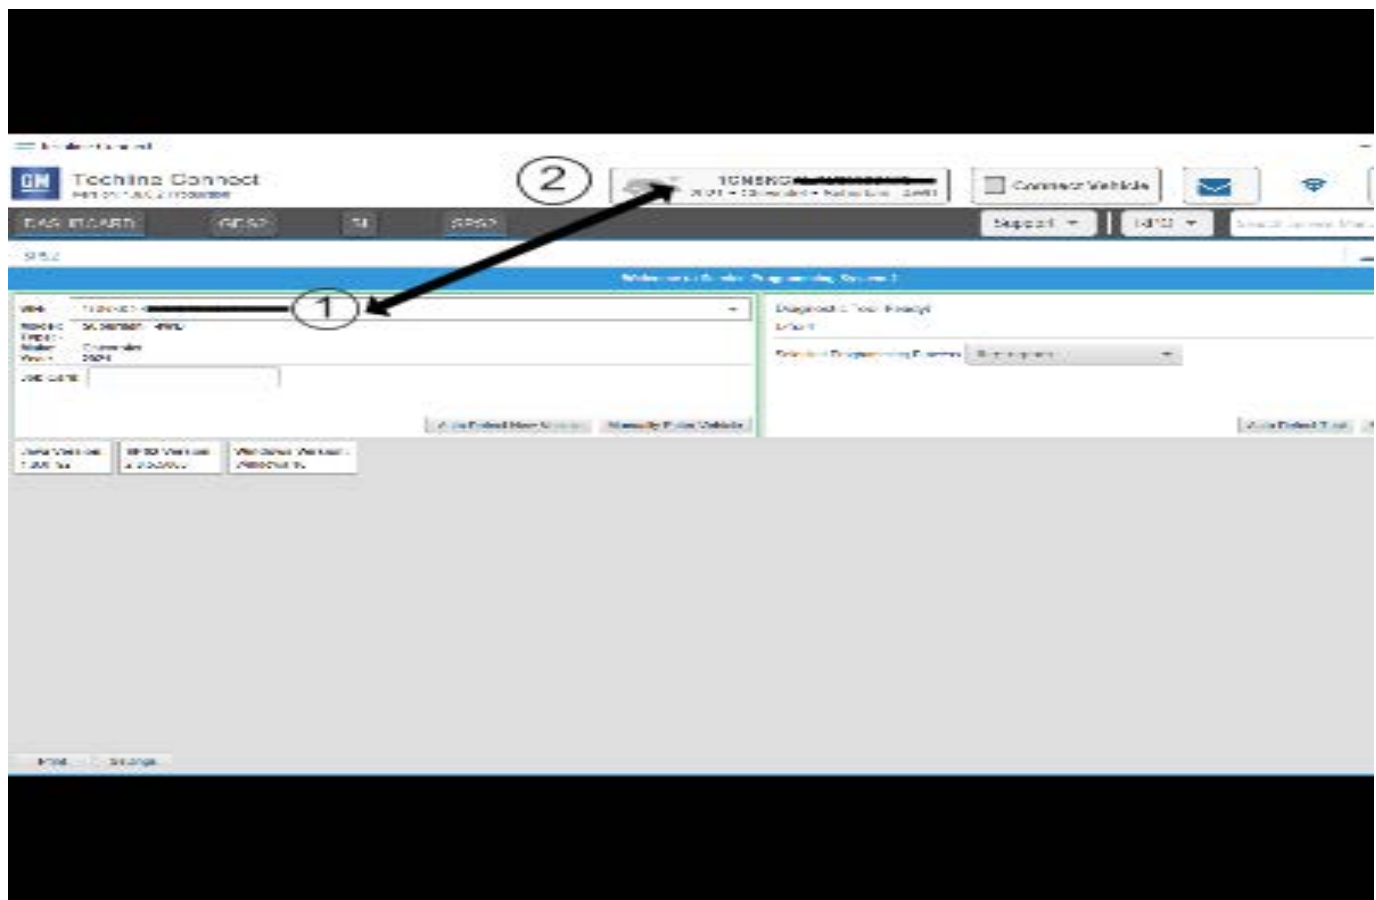
5743643

Caution: Be sure the VIN selected in the drop down menu (1) is the same as the vehicle connected (2) before beginning programming.

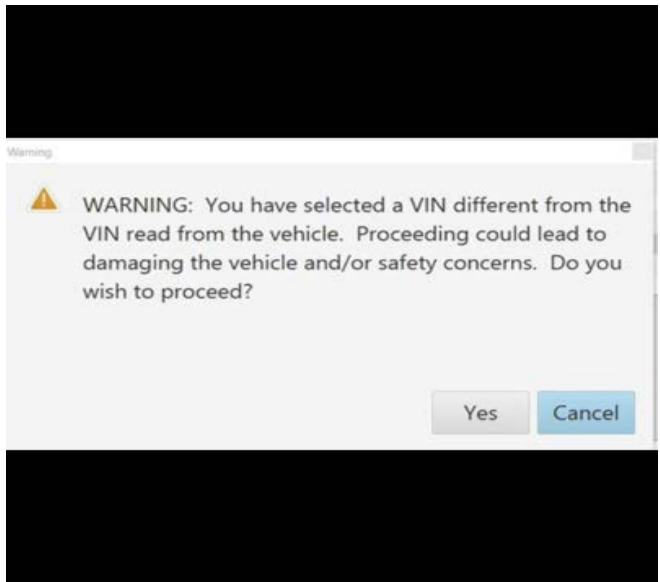
5877000

Important: If the vehicle VIN DOES NOT match, the message below will be shown
