# Service Bulletin

Bulletin No.: 22-NA-082

**Subject:** Malfunction Indicator Lamp Illuminated with DTC P06DD, P2B60, P26BB, P1098 Set

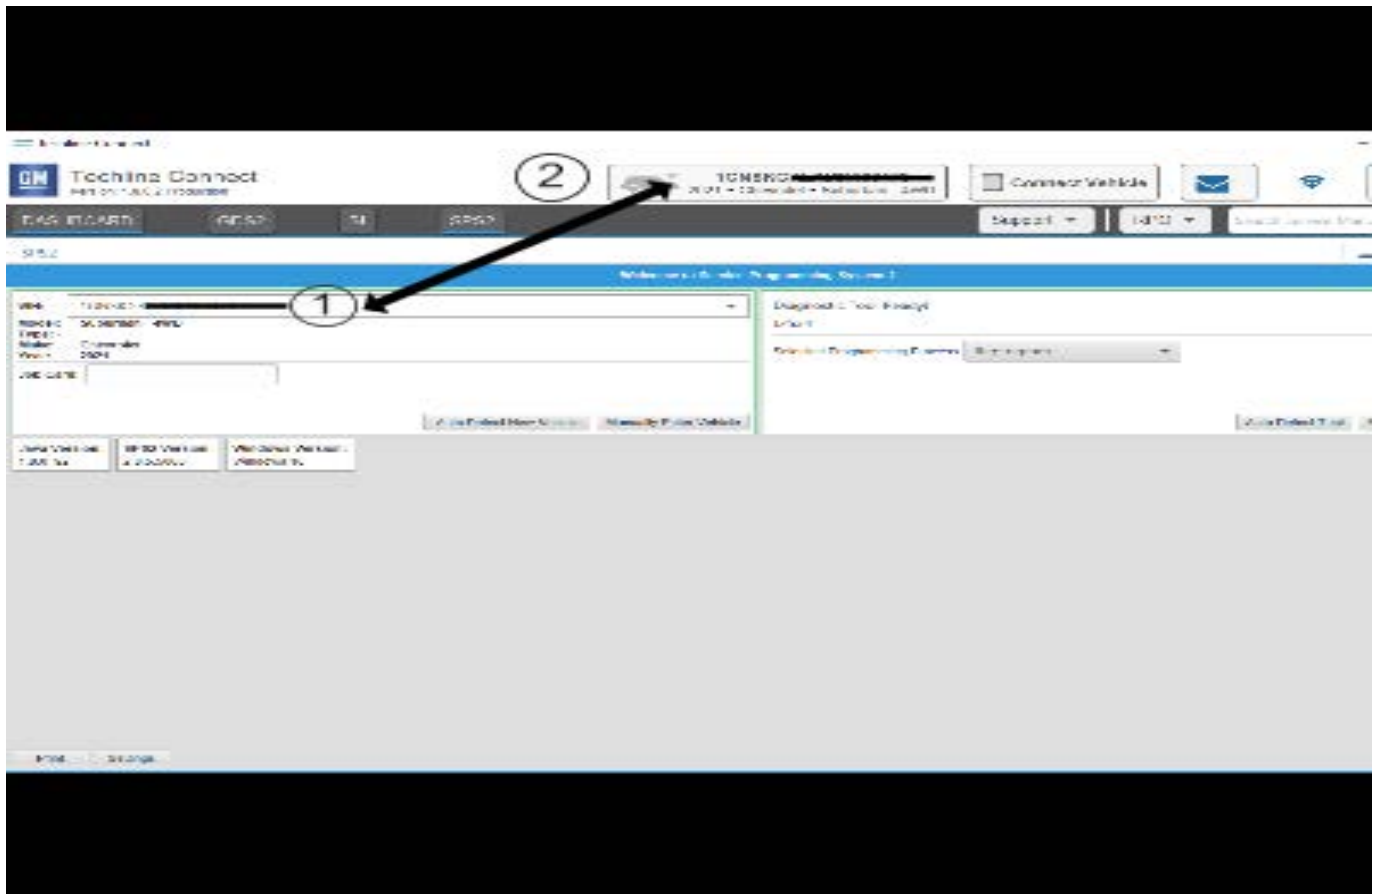
5743643

**Caution:** Be sure the VIN selected in the drop down menu (1) is the same as the vehicle connected (2) before beginning programming.

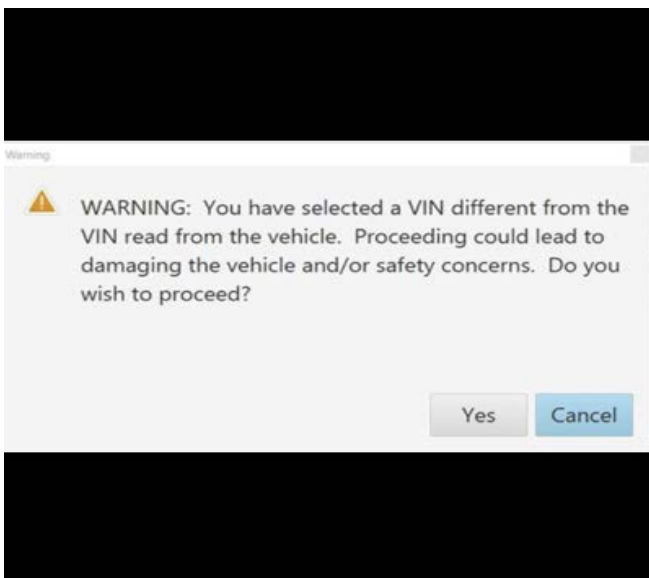
5877000

Important: If the vehicle VIN DOES NOT match, the message below will be shown
