## STAR ONLINE PUBLICATION

**Case Number: S2025000005 REV. A**

**Symptom/Vehicle Issue:** Malfunction Indicator Lamp (MIL) Illumination. Diagnostic Trouble Codes P0407 – EGR Sensor B Circuit Low, or P0408 – EGR Sensor B Circuit High Set

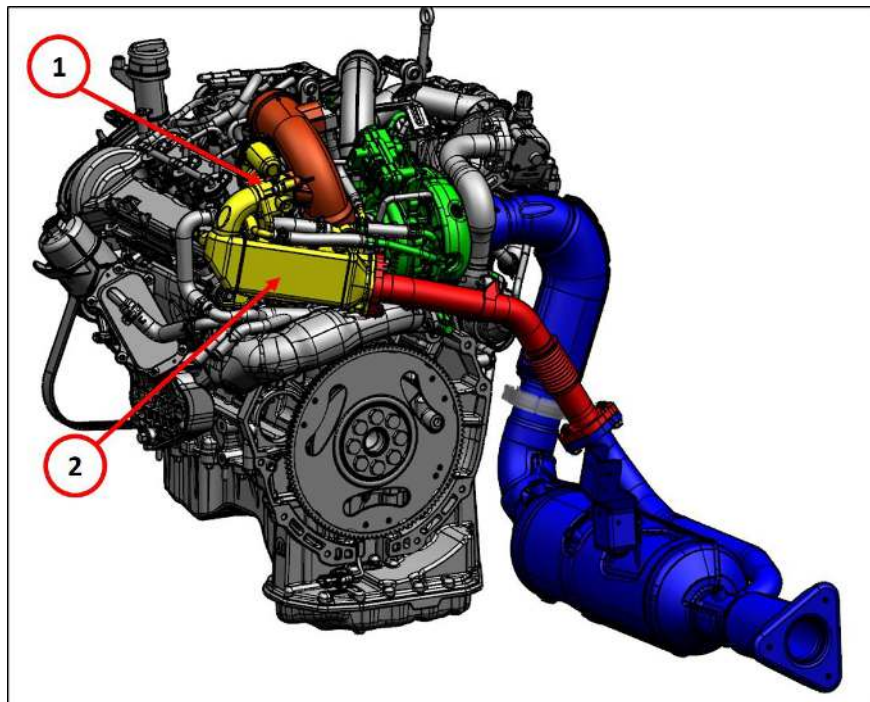
**Figure 1**

**NOTE: DTCs P0407, and P0408 are position sensor circuit faults for the Low Pressure (LP) EGR system. The LP EGR valve, and cooler are located on the driver's side rear of the engine. The High Pressure (HP) EGR system does not have an effect on these DTCs. Please ensure that the correct EGR system is being diagnosed prior to replacing any parts.**

Please refer to (Figure 1) for the location of the LP EGR system.

1. LP EGR Valve.
2. LP EGR Cooler.
