## STAR ONLINE PUBLICATION

**Case Number:** S2018000001 REV. A

**Symptom/Vehicle Issue:** Malfunction Indicator Lamp (MIL) Illumination. Diagnostic Trouble Code (DTC) P26FB – EGR Cooler Bypass Control Stuck Closed Bank 1 Set.

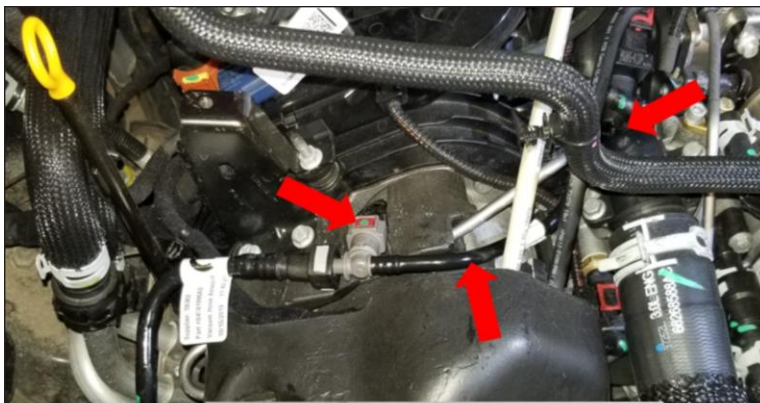
Fig. 1

1. Perform normal published diagnostics for P26FB.
2. During your diagnosis, closely inspect the vacuum supply tube to the EGR Cooler Bypass Valve remote solenoid for blockage ([See Fig. 1](#))

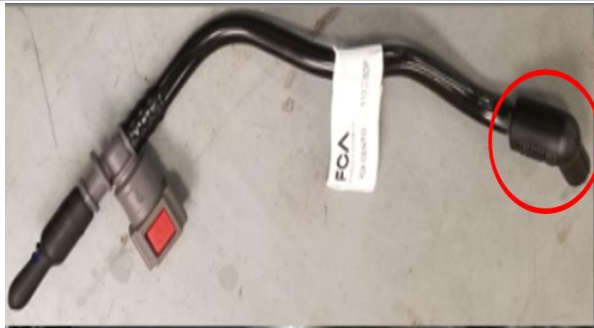
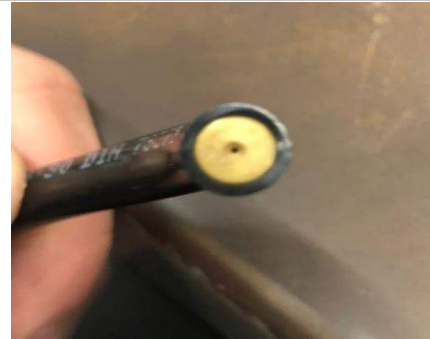
**NOTE:** There is a .6mm brass orifice in the vacuum tube assembly at the elbow connection. Some resistance in air flow is normal ([See Fig. 2 and 3](#)).

3. Carefully inspect the vacuum tube for the presence of a blockage in the orifice. This can be done by attempting to blow light air pressure through the tube assembly.
4. If the orifice in the tube is found blocked, please replace the tube assembly. **DO NOT** attempt to remove the blockage.
5. Inspect the internal integrity of the bypass valve by performing the following steps:
  - a. Gain access to the bypass valve vacuum actuator, and using your thumb, actuate the actuator in and out. (See Fig. 4). Ensure that the valve operates smoothly without sticking.
