**NUMBER:** 08-018-21

Video Routing Module (VRM) Enhancements For Rear Seat Entertainment System

This bulletin involves updating the VRM software level to **\*\*20.30.14\*\***.

2017 - **\*\*2021\*\*** (RU) Chrysler Pacifica

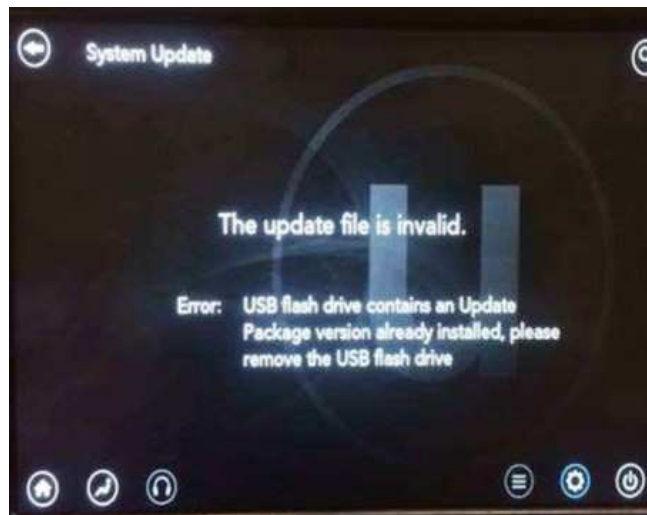
**NOTE: If the USB flash drive is left in the port after system reboot, there will be a pop-up on the rear seat back video screen that states "The update file is invalid" (Fig. 4) . This is not a concern as the system is already up to date.**

Fig. 4  
Rear Seat back Video Screen Error

11. The update may take 13 minutes and no other actions will be needed.
12. After the update is done downloading, the screen will display "Update successful". Remove USB flash drive.
