# Technical Service Bulletin

## 21 Mil on - P0299 Negative pressure deviation, turbocharger excessive wastegate play

21 13 11 2031245/2 March 6, 2013. Supersedes Technical Service Bulletin Group 21 number 12-10 dated October 25, 2012 for reasons listed below.

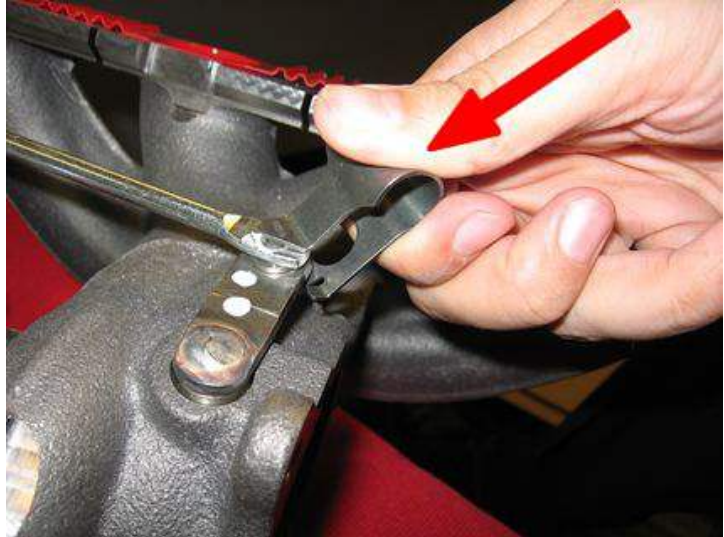
**Figure 1.** Fit the clip from the side.

1. Remove turbocharger as per ELSA instructions: *Repair Manual >> Engine / Engine Mechanical >> 21 Turbocharger, G-Charger >> Removal and Installation >> Turbocharger.*
2. Install clip **06J145220B** on a replacement turbocharger's link plate and actuating rod joint as illustrated (Figures 1 and 2).

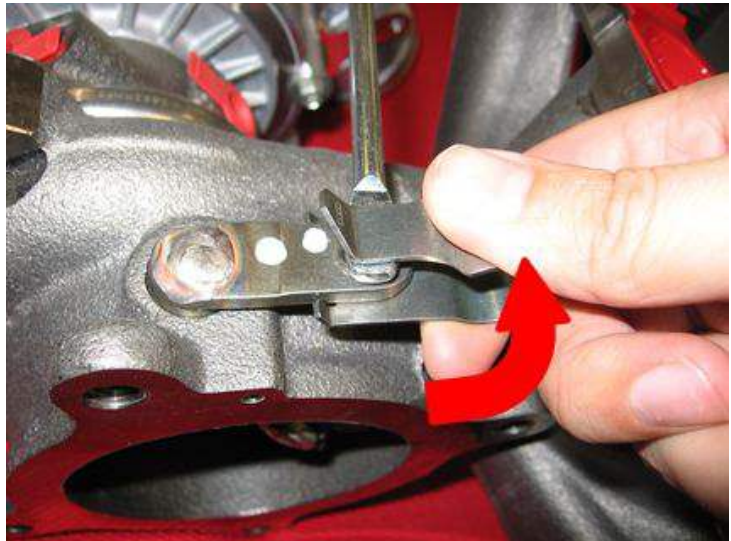
**Figure 2.** Turn the clip counter clockwise till the lugs slot in.

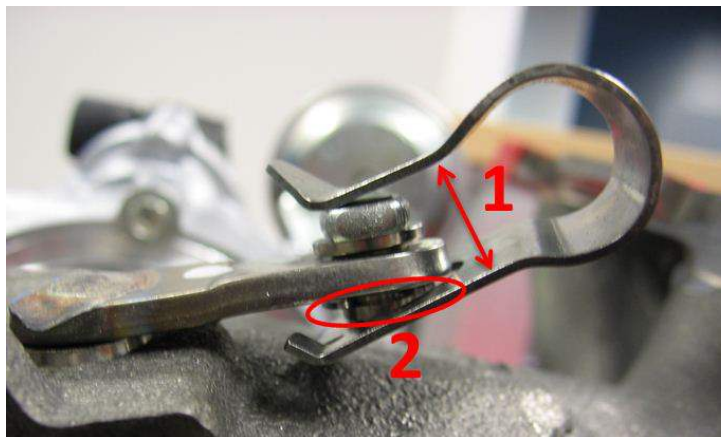
**Figure 3.** (1) Maximum opening of clip, (2) Position of original circlip

- The spring clip must not be overstretched. The maximum opening of the spring clip is 14 mm (Figure 3, 1).
- The spring clip must be replaced after every removal.

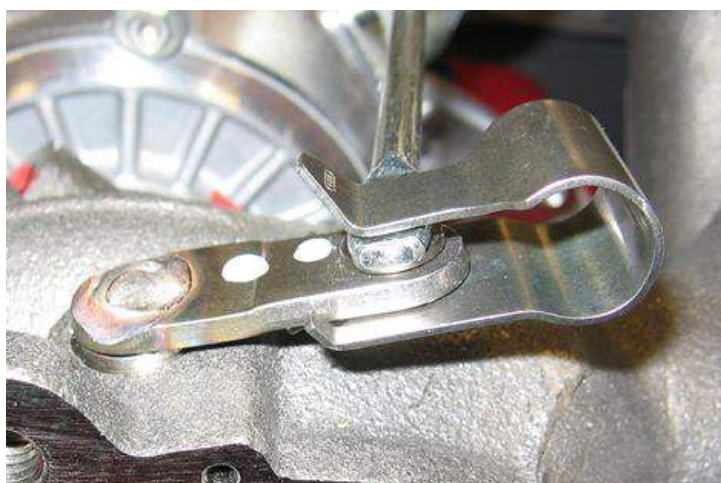
**Figure 4.** Correctly-fitted clip.

3. After fitting the spring clip, check for correct fit (Figure 4).

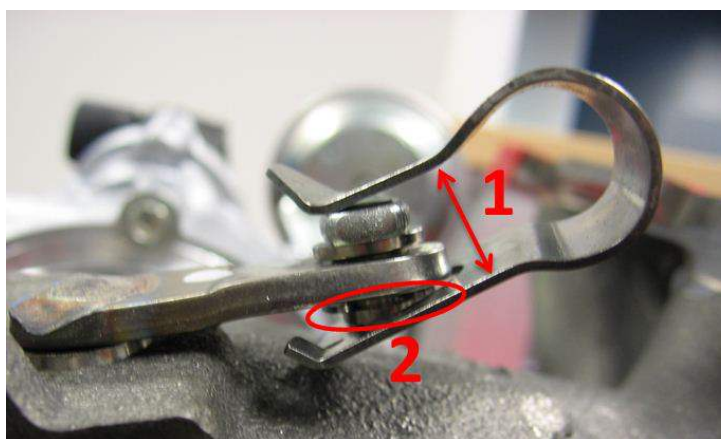
**Figure 5.** (1) Maximum opening of clip, (2) Position of original circlip

4. After fitting the spring clip, check the position of the original circlip (Figure 5, 2) and correct it if necessary.
