# Technical Service Bulletin

## 21 Mil on - P0299 Negative pressure deviation, turbocharger excessive wastegate play

21 13 12 2031245/3 April 1, 2013. Supersedes Technical Service Bulletin Group 21 number 13-11 dated March 6, 2013 for reasons listed below.

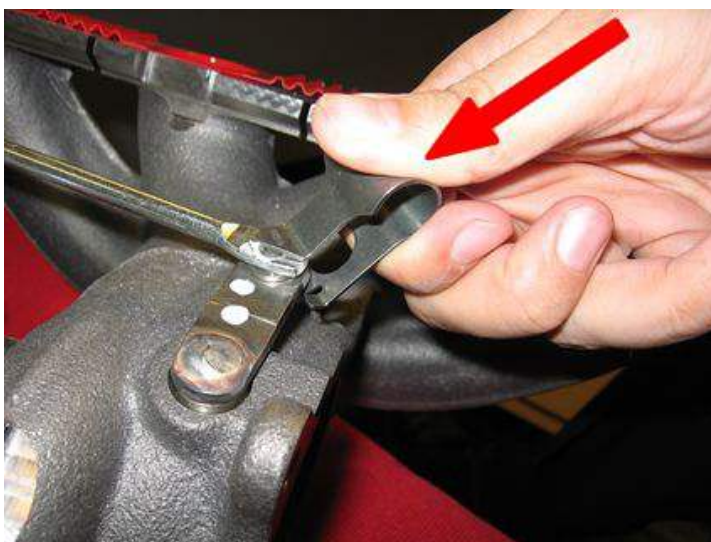
**Figure 1.** Fit the clip from the side.

1. Remove turbocharger as per ELSA instructions: *Repair Manual >> Engine / Engine Mechanical >> 21 Turbocharger, G-Charger >> Removal and Installation >> Turbocharger.*
2. Install clip **06J145220B** on a replacement turbocharger's link plate and actuating rod joint as illustrated (Figures 1 and 2).

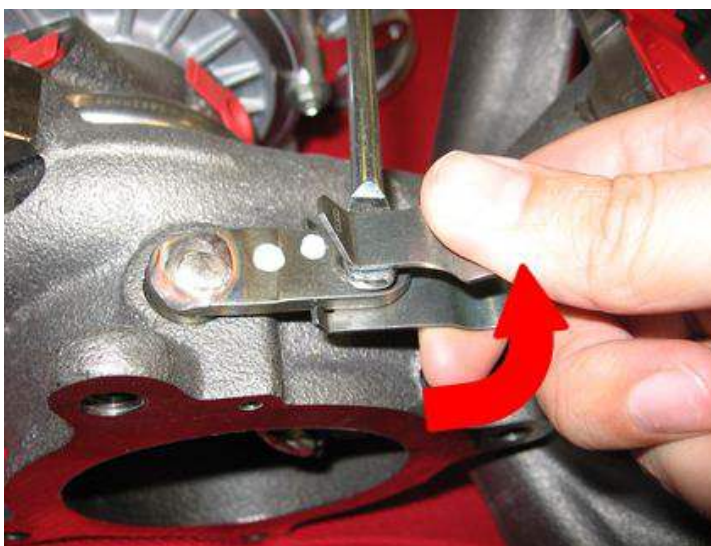
**Figure 2.** Turn the clip counter clockwise till the lugs slot in.

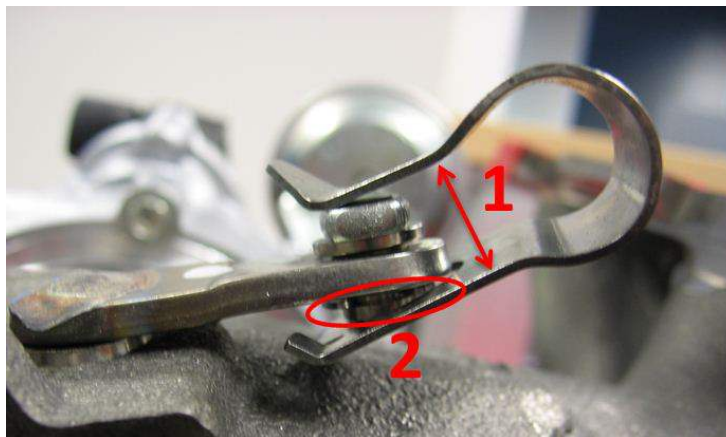
**Figure 3.** (1) Maximum opening of clip, (2) Position of original circlip

- The spring clip must not be overstretched. The maximum opening of the spring clip is 14 mm (Figure 3, 1).
- The spring clip must be replaced after every removal.

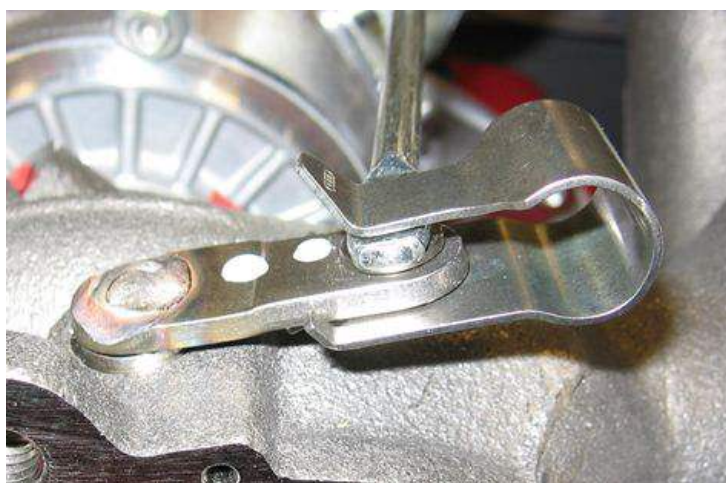
**Figure 4.** Correctly-fitted clip.

3. After fitting the spring clip, check for correct fit (Figure 4).

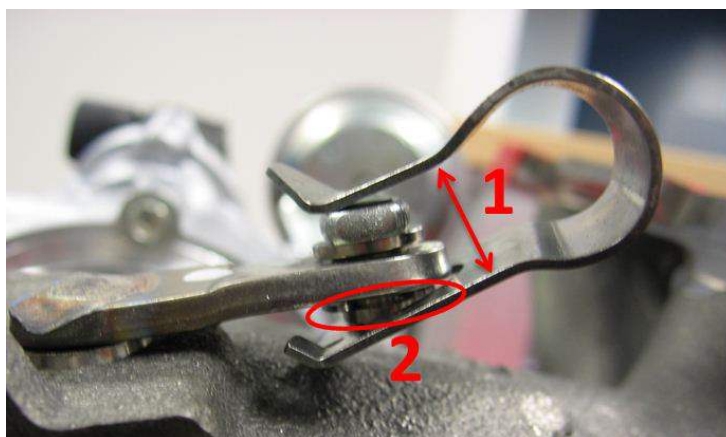
**Figure 5.** (1) Maximum opening of clip, (2) Position of original circlip

4. After fitting the spring clip, check the position of the original circlip (Figure 5, 2) and correct it if necessary.
