# Technical Service Bulletin

## 21 Mil on - P0299 Negative pressure deviation, turbocharger excessive wastegate play

21 13 14 2031245/5 June 7, 2013. Supersedes Technical Service Bulletin Group 21 number 13-13 dated April 4, 2013 for reasons listed below.

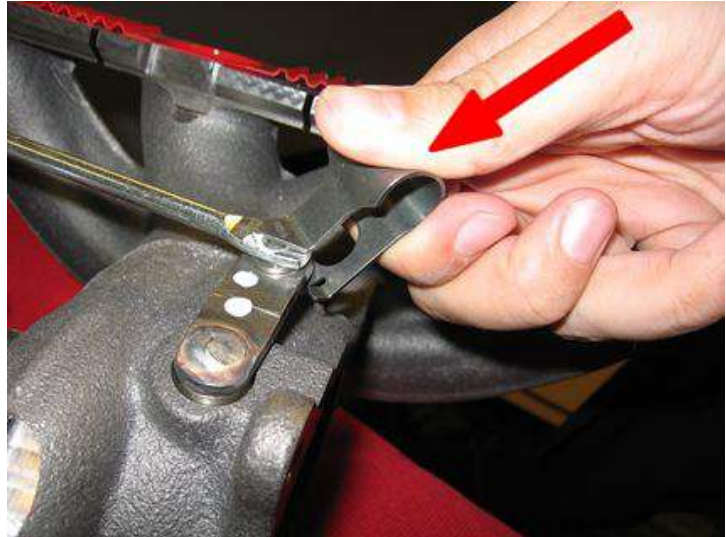
**Figure 1.** Fit the clip from the side.

1. Remove turbocharger as per ELSA instructions: *Repair Manual >> Engine / Engine Mechanical >> 21 Turbocharger, G-Charger >> Removal and Installation >> Turbocharger.*
2. Install clip **06J145220B** on a replacement turbocharger's link plate and actuating rod joint as illustrated (Figures 1 and 2).

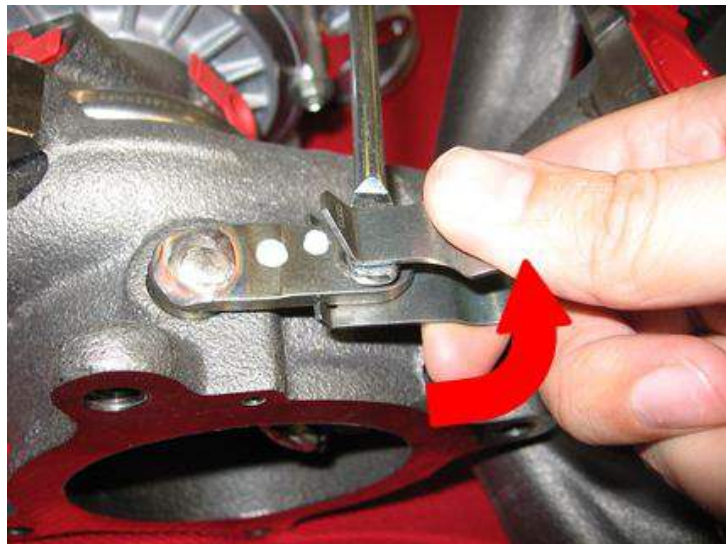
**Figure 2.** Turn the clip counter clockwise till the lugs slot in.

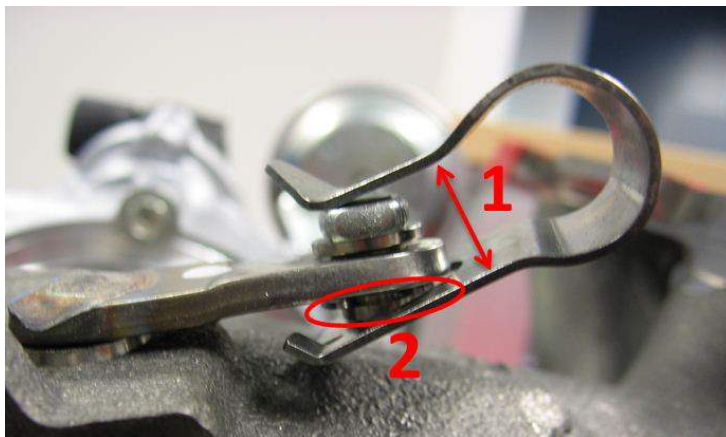
**Figure 3.** (1) Maximum opening of clip, (2) Position of original circlip

- The spring clip must not be overstretched. The maximum opening of the spring clip is 14 mm (Figure 3, 1).
- The spring clip must be replaced after every removal.

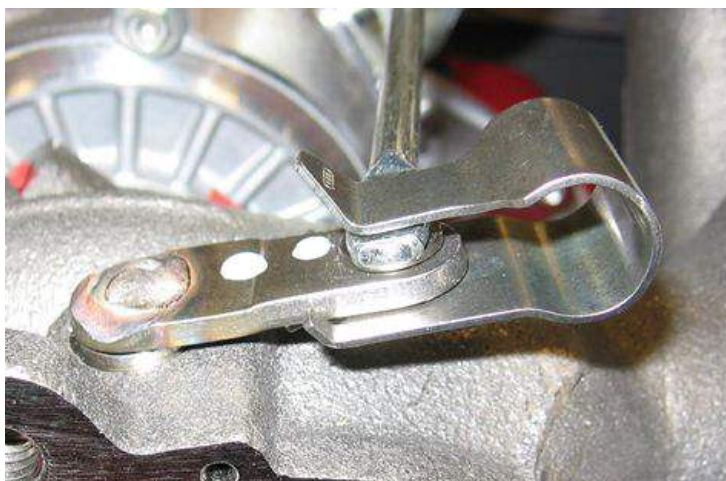
**Figure 4.** Correctly-fitted clip.

3. After fitting the spring clip, check for correct fit (Figure 4).

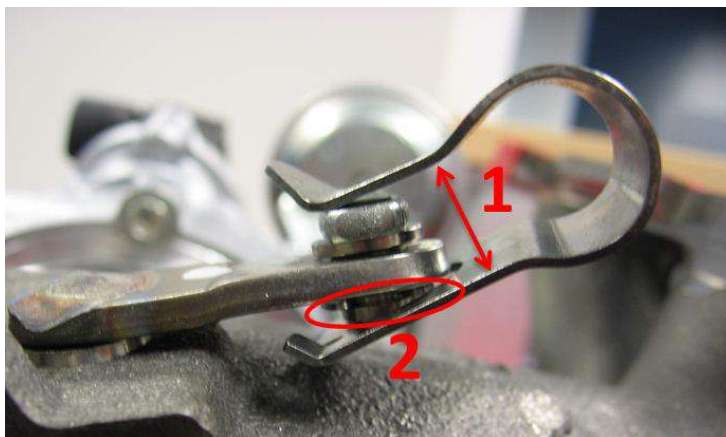
**Figure 5.** (1) Maximum opening of clip, (2) Position of original circlip

4. After fitting the spring clip, check the position of the original circlip (Figure 5, 2) and correct it if necessary.
