# Technical Service Bulletin

## 21 MIL on (DTC P0299 - negative pressure deviation); turbocharger excessive wastegate play

21 14 18 2031245/7 June 6, 2014. Supersedes Technical Service Bulletin Group 21 number 13-16 dated July 9, 2013 for reasons listed below.

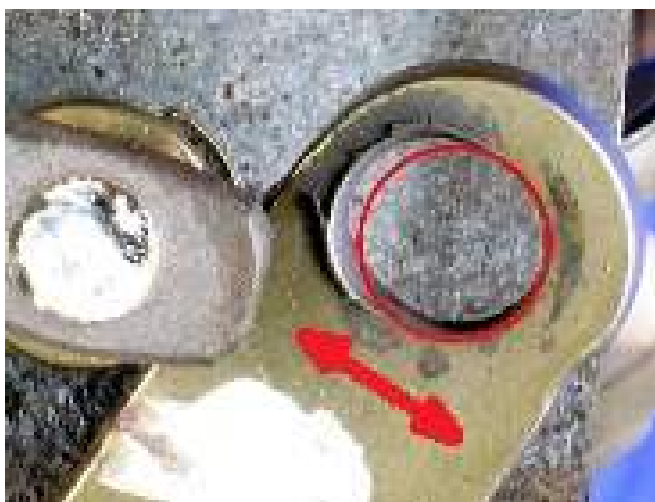
Under certain driving conditions, the linkage for the waste gate actuation can encounter excessive wear which leads to play at the waste gate flap. This leads to boost escaping through a loose flap, which sets **DTC P029900** (Negative Pressure Deviation).

- Verify the condition by confirming that **DTC P029900** is stored in the ECM, and that the wastegate link plate has visible play in the direction of the actuating rod (Figure 1). Review the attached video clip for an example.

**Figure 1.** Worn eye on wastegate link plate allowing excessive play.

2. Remove turbocharger according to the instructions in ElsaWeb: *Repair Manual >> Engine / Engine Mechanical >> 21 Turbocharger, G-Charger >> Removal and Installation >> Turbocharger.*
3. Install clip **06J145220B** on a new, replacement turbocharger's link plate and actuating rod joint as illustrated (Figures 2 and 3).
