# Technical Service Bulletin

## 21 MIL on (DTC P029900 - wastegate linkage disconnected)

21 14 21 2039006/2 November 26, 2014. Supersedes Technical Service Bulletin Group 21 number 14-20 dated November 17, 2014 for reasons listed below.

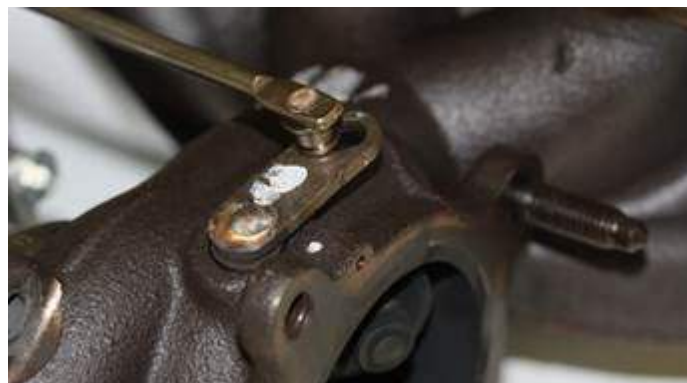
- MIL on.
- Customer may report a reduction in power.
- **DTC P029900** (Turbo/Super Charger Underboost) is stored in the engine control module (ECM), J623 (address word 01).

The circlip connecting the turbo wastegate actuator rod and the wastegate flap lever can fall off due to low tension of the clip. Consequently, the wastegate linkage becomes disconnected, causing MIL on and DTC P029900.

*Figure 1. Disconnected wastegate linkage.*

1. Visually check that the wastegate linkage is disconnected (Figure 1) before proceeding with the help of a mirror or boroscope. If this is not the case, this bulletin does not apply.

2. Remove catalyst according to ELSA instructions to gain access to turbocharger wastegate linkage.
3. Reconnect wastegate linkage and secure with a new circlip (separately available in ETKA).
