# Technical Service Bulletin

34 Function restriction with event memory entry P071800 - P276800 (symptom 20736 - 20737)

34 22 59 2067653/1 July 29, 2022.

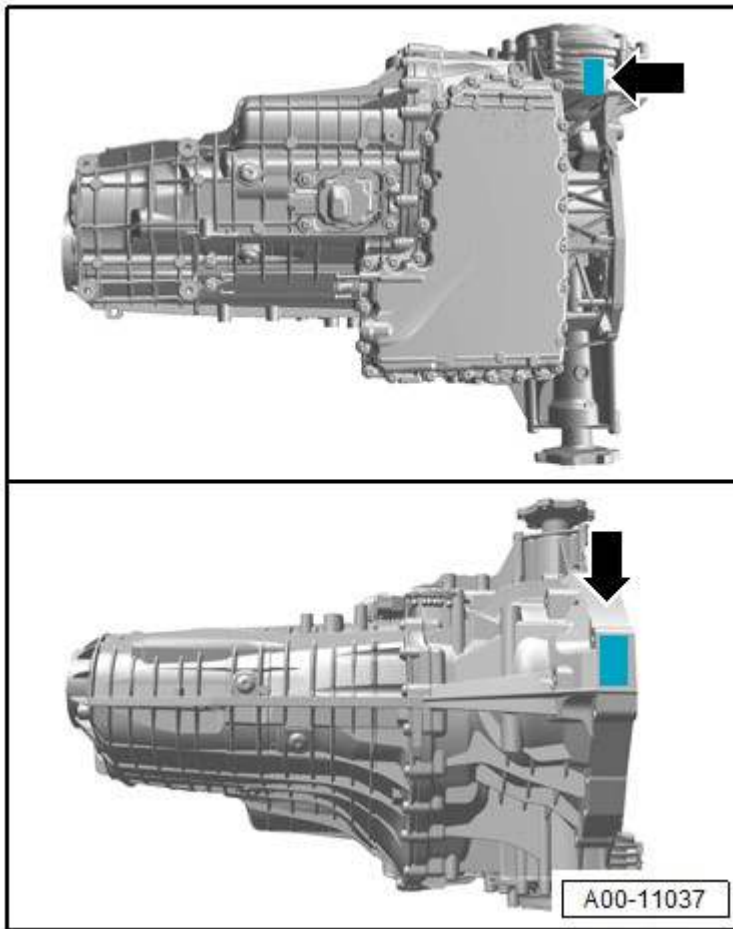
*Figure 1. Locations of data stampings.*

- **First determine if the Transmission was built within date range of June 15, 2020 and March 31, 2021.**
- Check one of the transmission data stamps which are located on the bottom of the front differential and the top of the bellhousing (Figure1).

The Data Stamping contains the following information:

Production Data: 006SVHC021170K180228

Transmission Code: SVH

Serial Number: C021170K

**Production Date:** 28.02.2018. Day/Month/Year format. Example shown would be February 28<sup>th</sup> 2018.
