2021-2022MY  
Sorento (MQ4a) w/BSD

308

July 2022

**SERVICE ACTION: REAR CORNER RADAR UNIT  
BODY SEALER INSPECTION & REPAIR (SA503)**

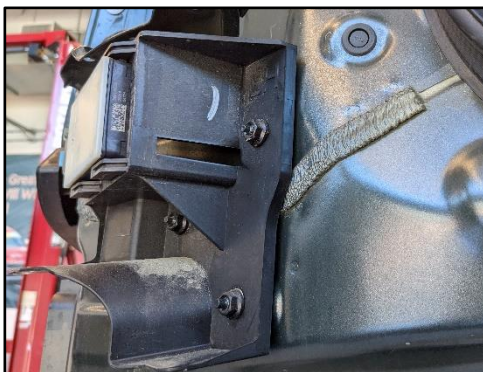
This bulletin provides information to inspect both rear (LH & RH) corner radar unit mounting body sealer surface on some 2021-2022MY Sorento (MQ4a) vehicles equipped with rear Blind Spot Detection (BSD) System, produced from November 30, 2021 through June 30, 2022, which may have excess body sealer applied during assembly causing improper mounting angle of the rear corner radar unit. An improperly mounted rear radar unit may cause the vehicle to exhibit a MIL 'ON' with DTC C270954. Follow the procedure outlined in this publication to inspect and, if necessary, file down the seam sealer behind the bracket. Before conducting the procedure, verify that the vehicle is included in the list of affected VINs.

Rear corner radar unit bracket  
body sealer interference.

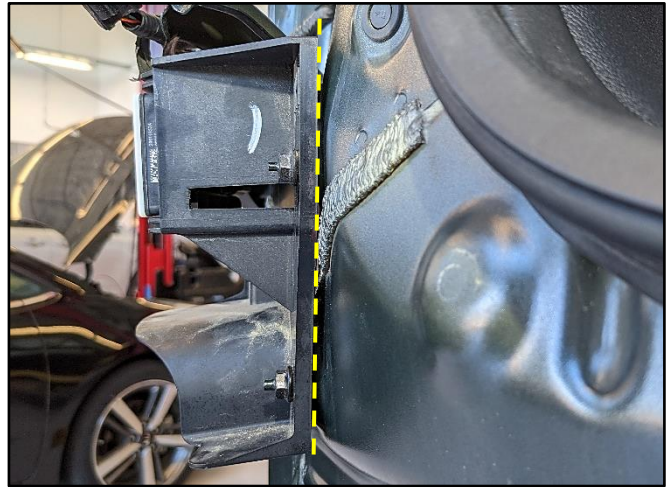
Note that the rear corner radar bracket mounting area is ‘flat’ over the body sealer. Excessive body sealer **(NG)** will cause the radar angle to aim improperly, resulting in a MIL ‘ON’ with DTC C270954.

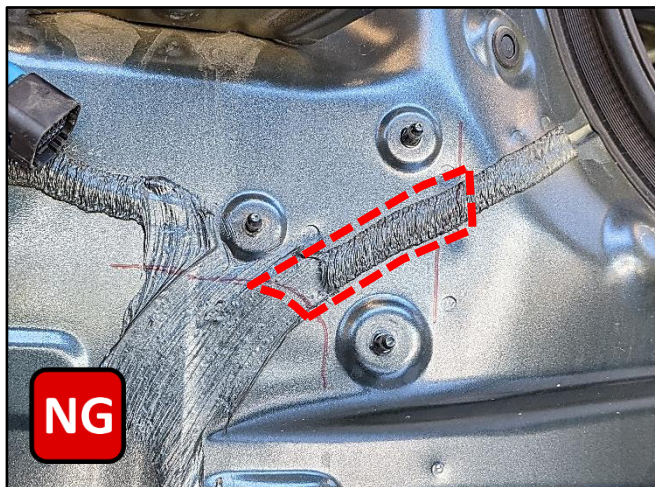
4. Inspect the surface of the rear radar bracket mounting area shown for excess body sealer.

Excessive body sealer will cause the radar angle to aim improperly.

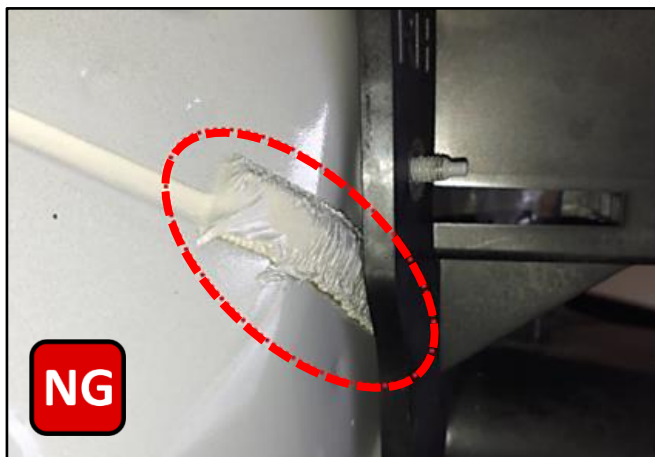
- If the body sealer exceeds thickness of 1.5mm (NG) and causes the rear radar bracket to mount improperly and/or DTC C270954 was stored, then proceed to step 5a/5b.

- 5a. Using a small sander/grinding pad, reduce any excess body sealer until the rear corner radar bracket mounting surface is no longer obstructed by excess sealer.
- 5b. Repeat for the opposite side as needed.

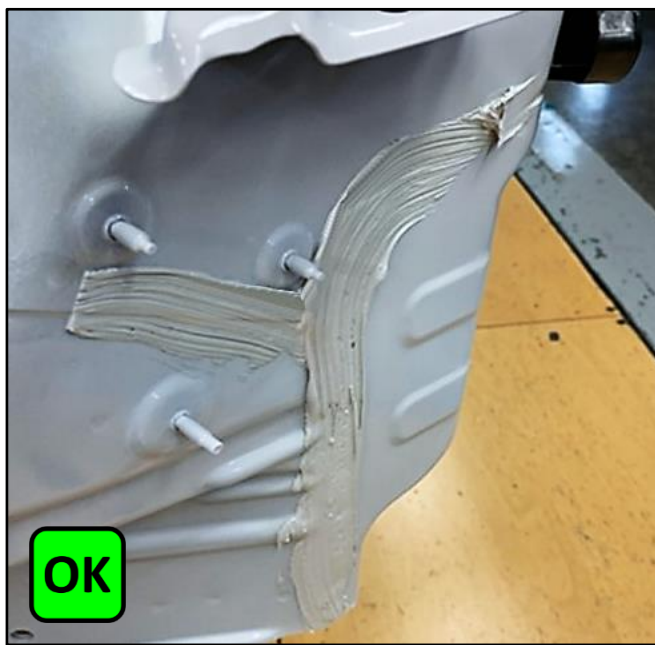
- If the body sealer is 1.4mm thick or less (OK) and the rear radar bracket mounts properly and/or DTC C270954 is not stored, then no further action is required. Proceed to step 8.
