# Service Bulletin

Bulletin No.: 22-NA-107

**Subject:** Service AWD Message in Driver Information Center (DIC) at Ignition On with DTC C056D Set

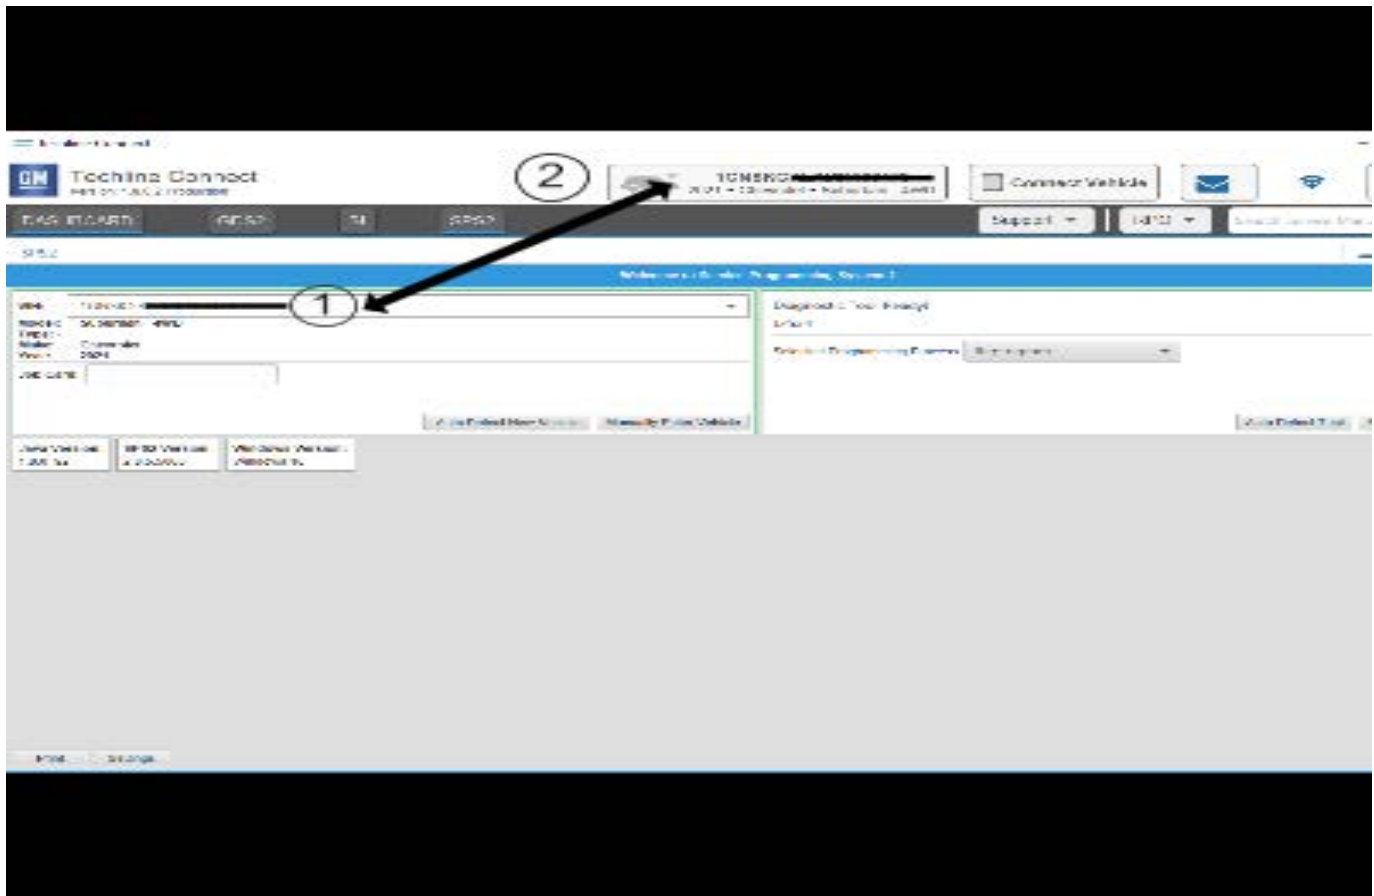
5743643

Caution: Be sure the VIN selected in the drop down menu (1) is the same as the vehicle connected (2) before beginning programming.

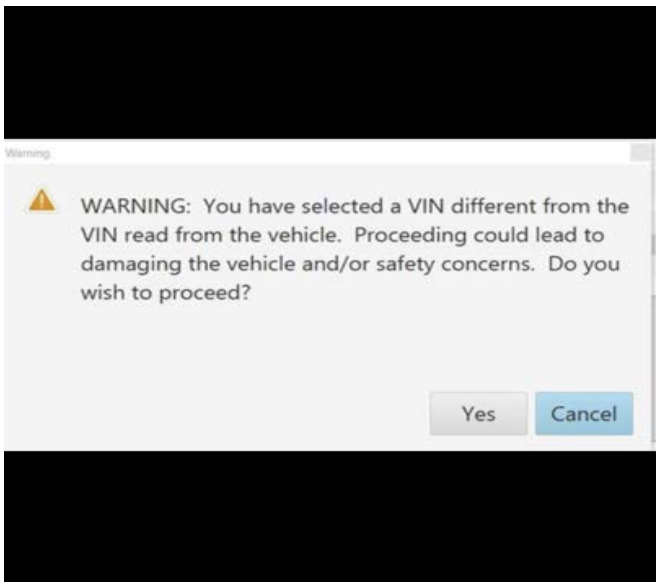
5877000

Important: If the vehicle VIN DOES NOT match, the message below will be shown.

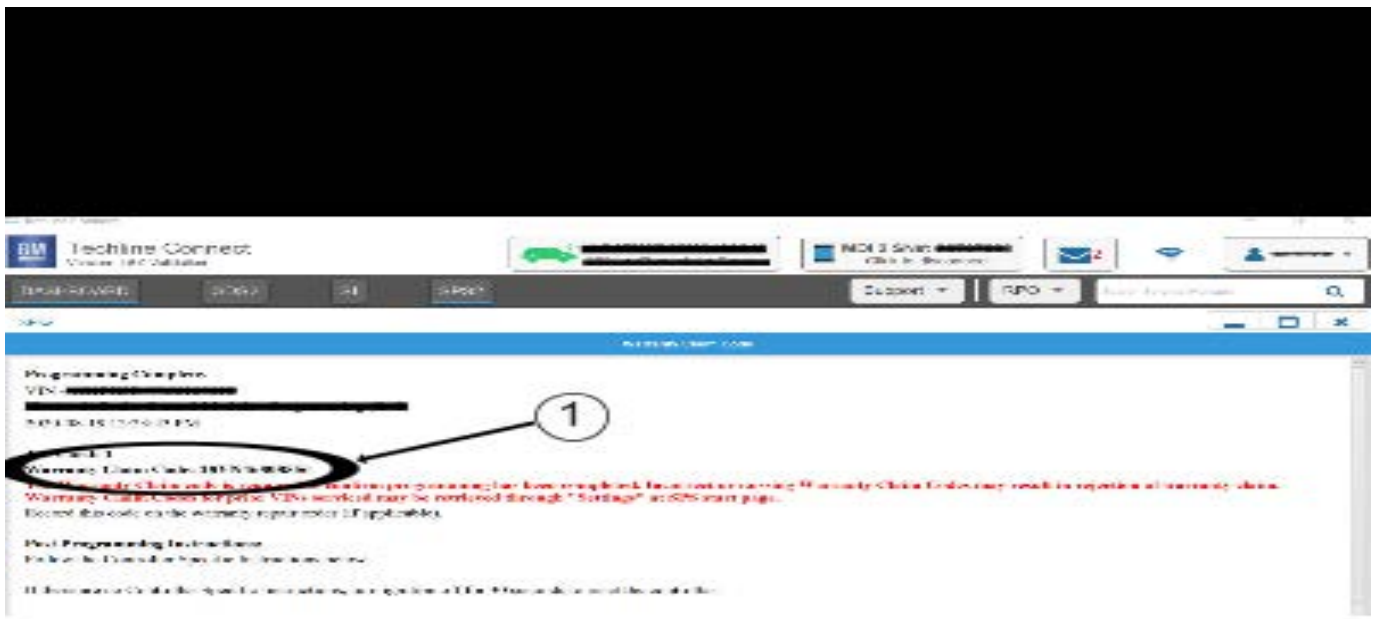
5644478

Important: To avoid warranty transaction rejections, you MUST record the warranty claim code provided on the Warranty Claim Code (WCC) screen shown above on the job card. Refer to callout 1 above for the location of the WCC on the screen.

2. Record the Warranty Claim Code on the job card for warranty transaction submission.
