# Service Bulletin

Bulletin No.: 21-NA-177

**Subject:** Service Power Steering Message Illuminated on Driver Information Center (DIC), DTC C0051 58 – Steering Wheel Angle Sensor Error Stored or in History

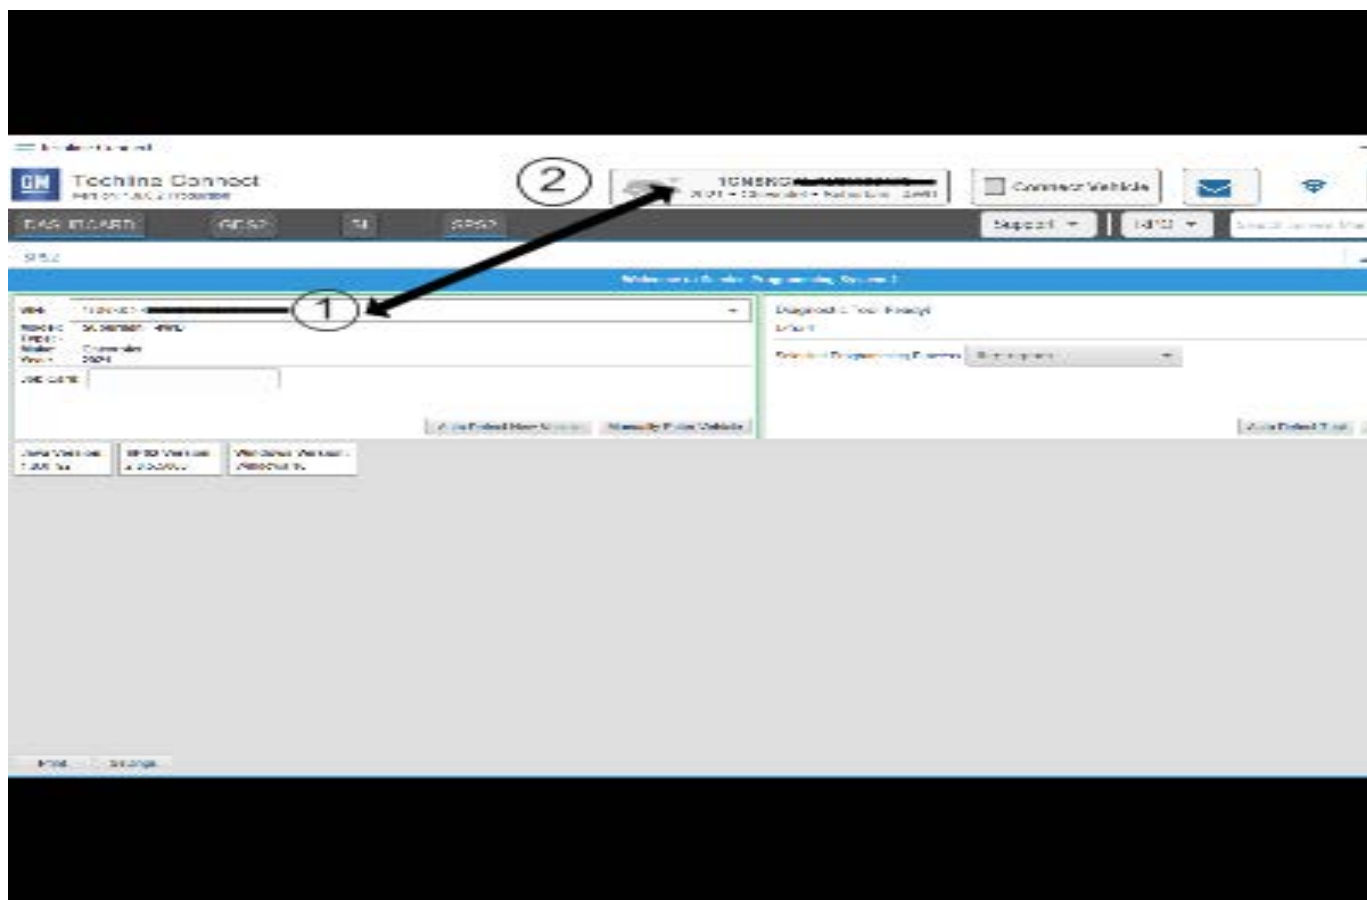
Caution: Be sure the VIN selected in the drop down menu (1) is the same as the vehicle connected (2) before beginning programming.
